# Environmental Due Diligence Report

Document version: June, 2026

## Georgia: Climate Smart Irrigation Sector Development Program

### Kvemo Samgori Left Main Canal Irrigation Scheme - Areas 5 and 6

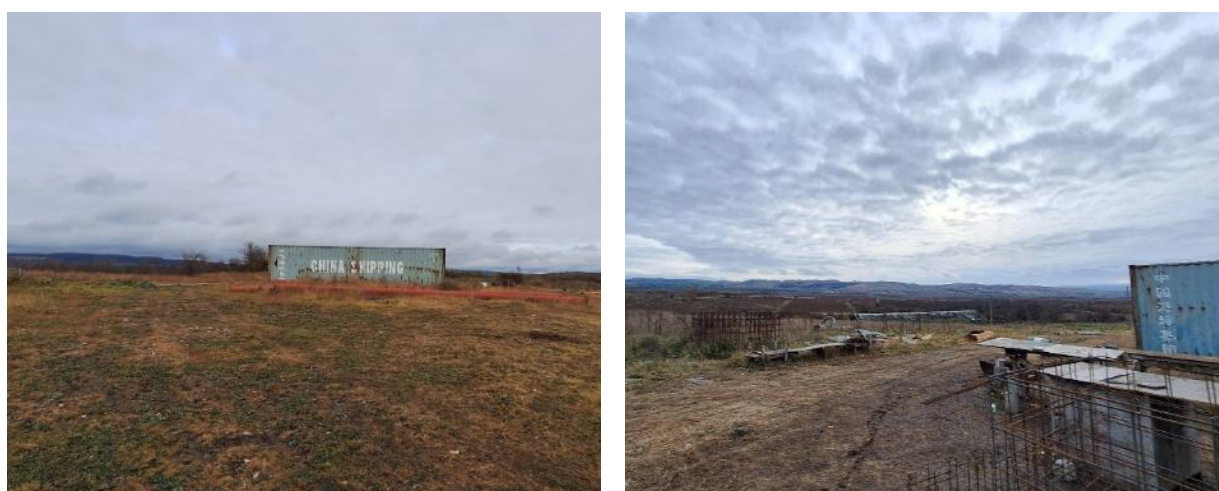
46. During the site visit in December 2025, it was noted that the camp has not been fully demobilized. A storage container, some materials, and waste remained on site.

*Figure 5. View of the Camp area used during rehabilitation (December, 2025)*

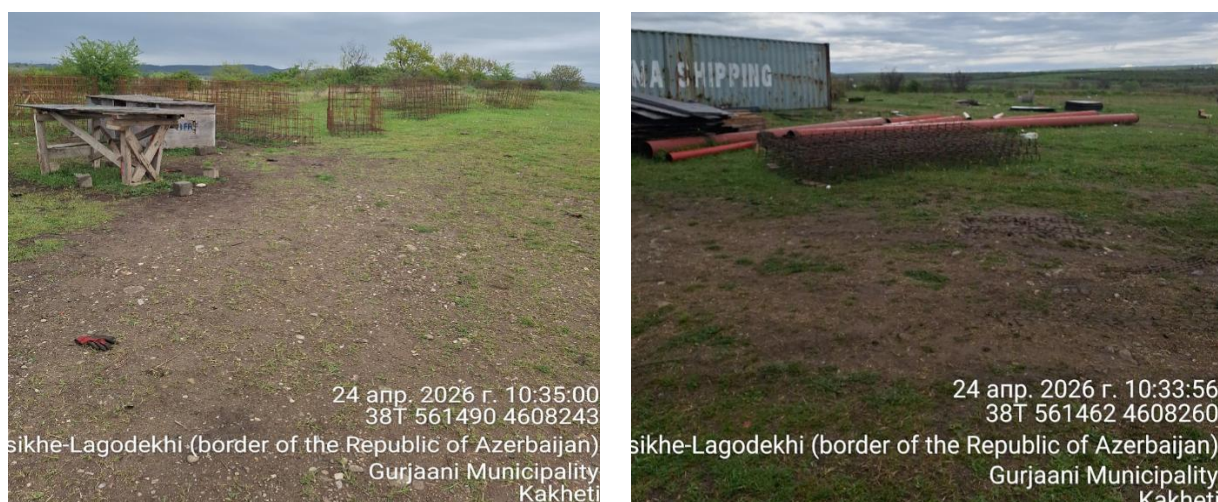
47. Subsequently, the site was rigorously re-inspected during the follow-up field visit on April 24, 2026. It is important to emphasize that no significant changes or improvements were observed between these two visits. Specifically, the area remains unfenced, and the temporary infrastructure has not been updated or expanded. Furthermore, almost no

48. During the April visit, various types of waste were still observed scattered across the camp area (this issue is elaborated upon in detail in the dedicated 'Waste Management' subsection below). Regarding potential soil contamination or oil spills, no significant issues or new spills were observed. In fact, unlike the December visit, the active growth of spring vegetation (grass) in April fully covered the site, and no visible signs of hydrocarbon contamination or recent leaks were detected on the ground.
49. Comparative general views of the area used for the camp during both the December 2025 and April 2026 field visits are shown below.

*Figure 6. View of the Camp area used during rehabilitation (April, 2026)*

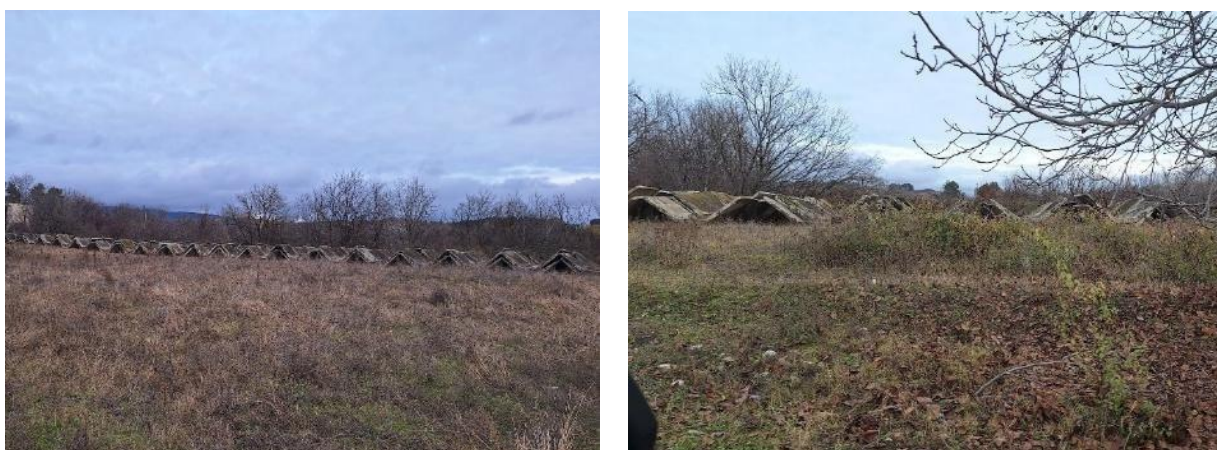
*Figure 7. Temporary storage area for dismantled concrete structures during rehabilitation (December, 2025)*

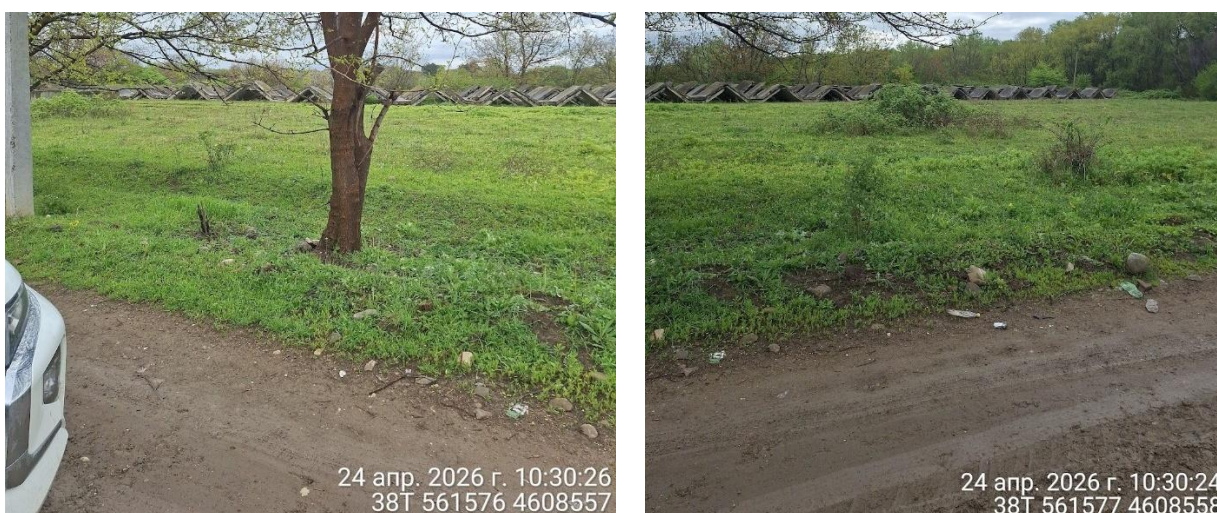
60. The follow-up field audit conducted on April 24, 2026, confirmed that the condition of this temporary storage area remains completely unchanged since the initial December 2025 visit. No new materials, additional waste, or hazardous substances have been placed at this location.

*Figure 8. Temporary storage area for dismantled concrete structures during rehabilitation (April, 2026)*

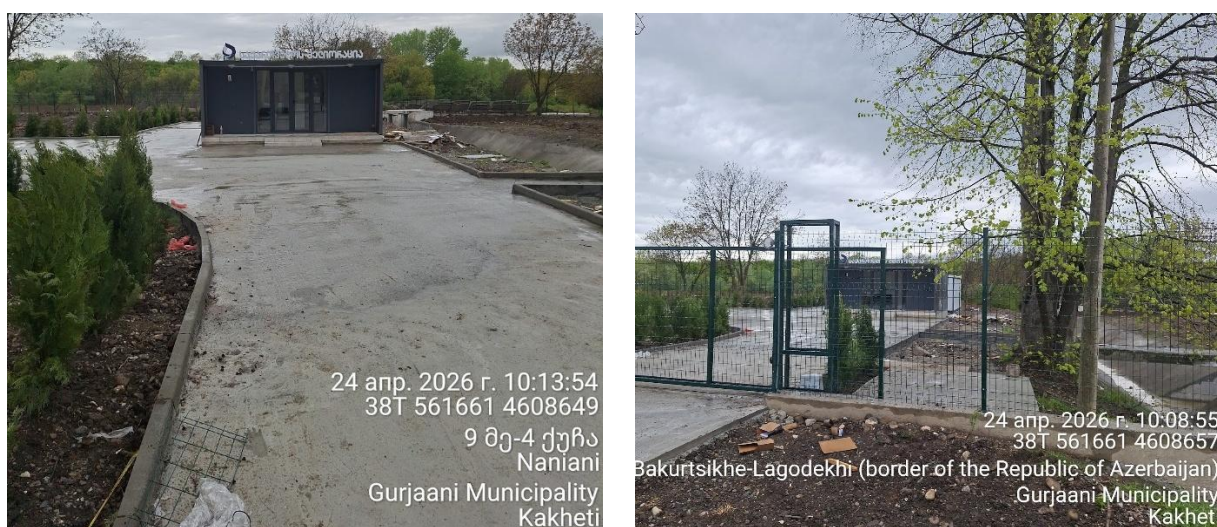
66. Within the fenced perimeter, various types of scattered non-hazardous construction waste from the recent works were observed. The specific details regarding this finding, along with the necessary corrective measures, are elaborated upon in the dedicated 'Waste Management' subsection of this report.

*Figure 9. GA New Service Center Building (April, 2026)*

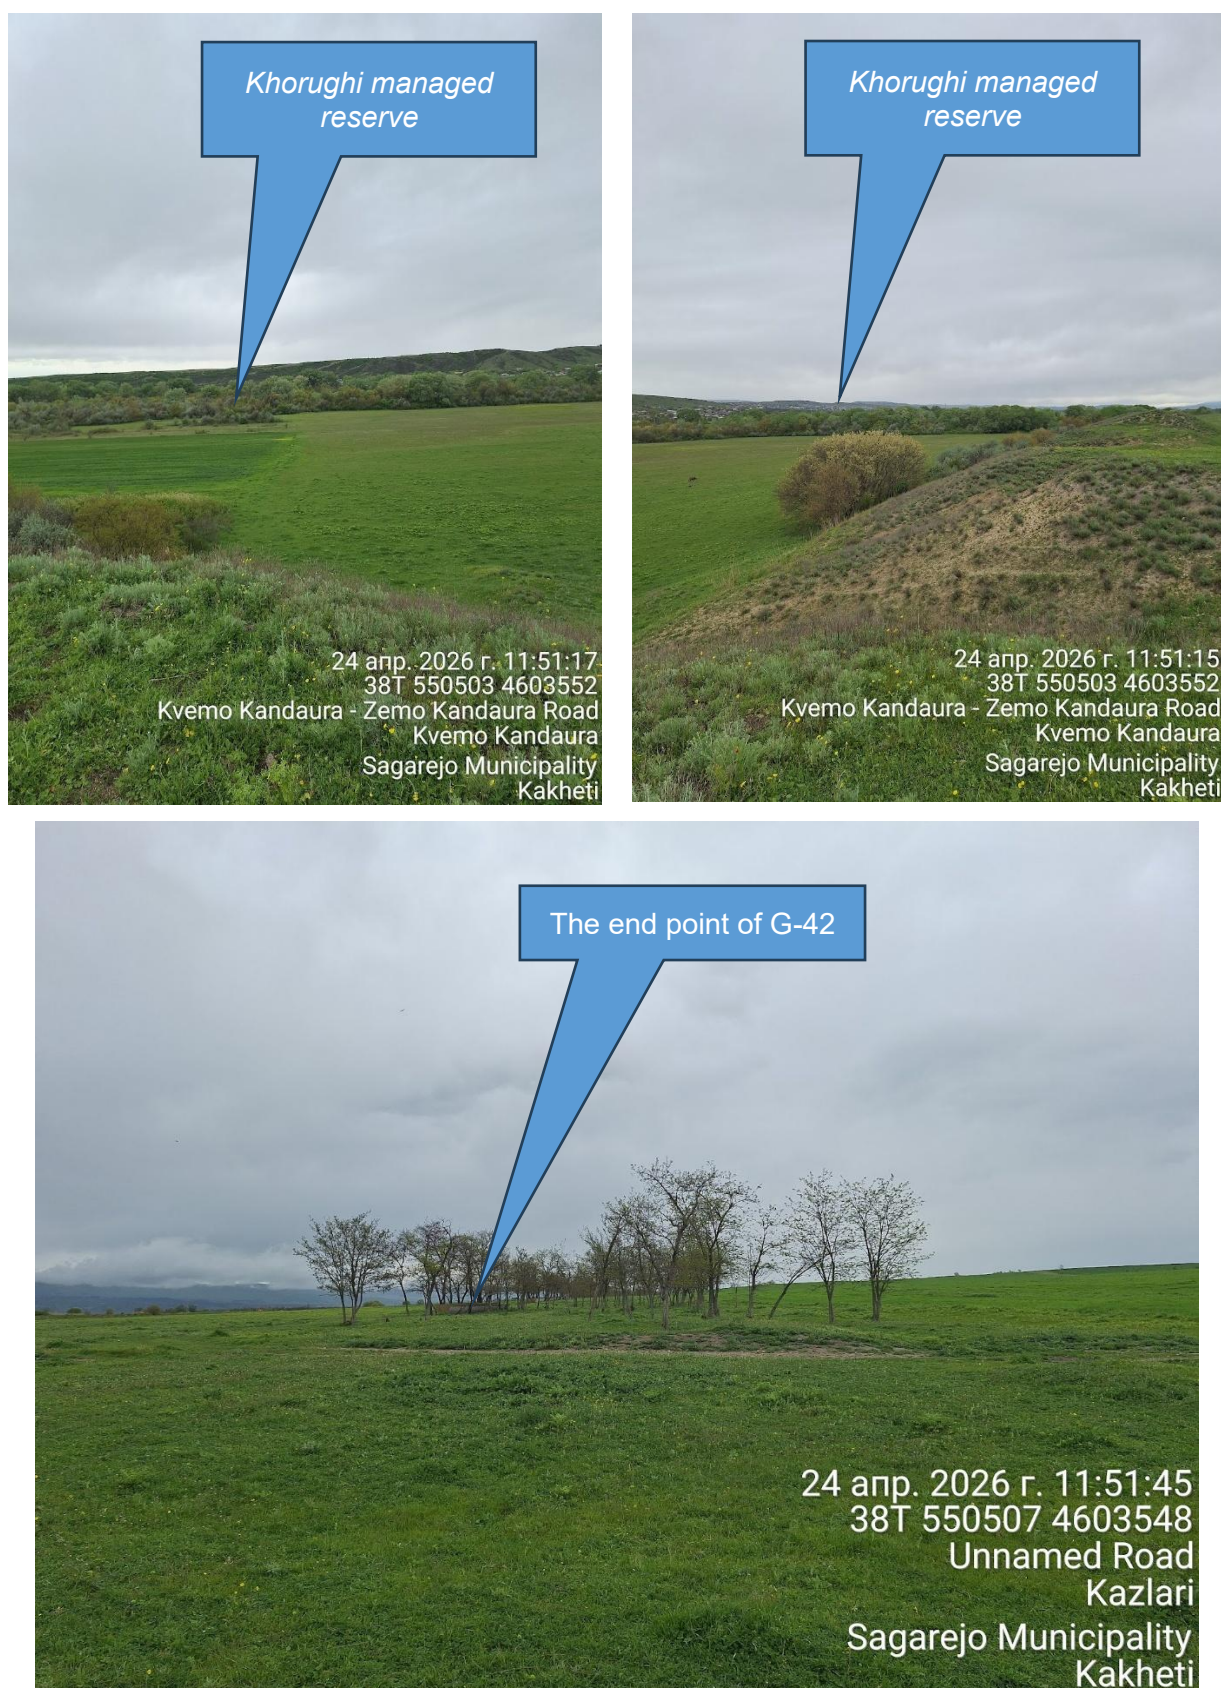
Figure 15. The boundary of the Korughi Managed Reserve interfacing with the untouched, un-rehabilitated segment of the G-42 canal, confirming the absence of construction impacts (April 24, 2026).

145. This pristine status is firmly corroborated by the official spatial KMZ map provided by GA (detailed in Section A) and the coordinate-stamped photographic evidence capturing the un-rehabilitated canal interfacing with the reserve boundary (see Figure 15 above).

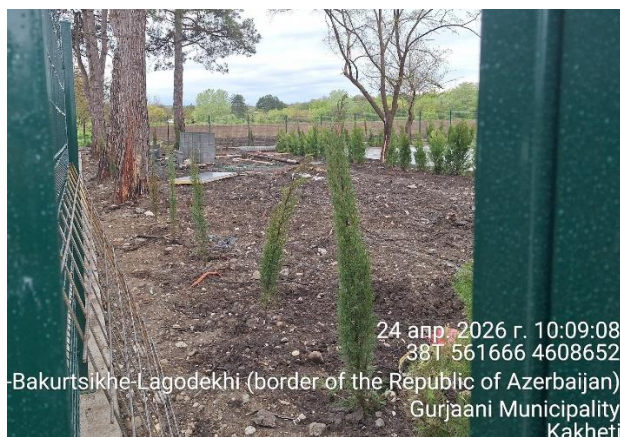
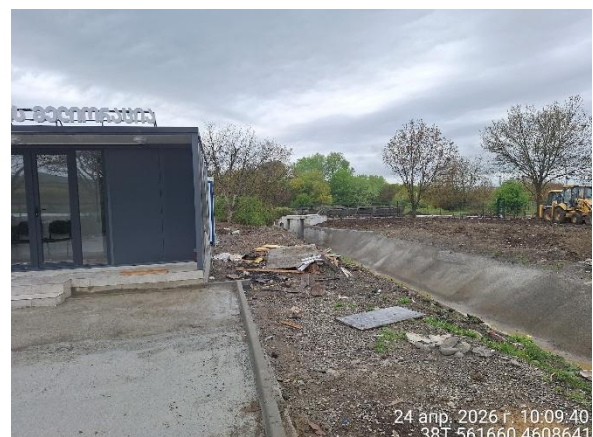
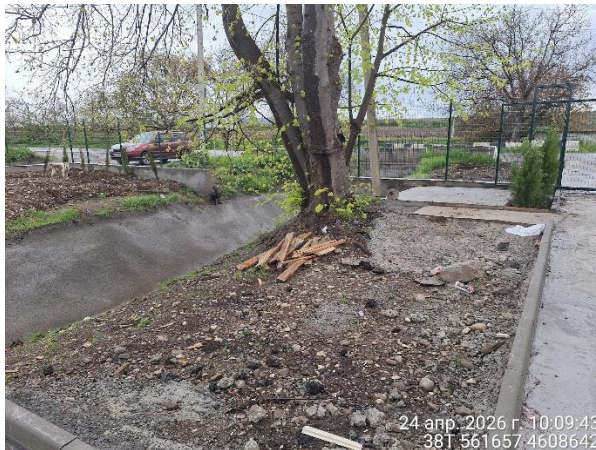
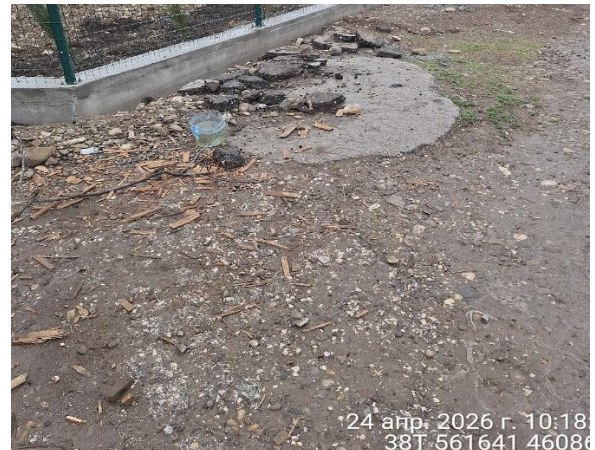
Figure 16. Waste in the new GA Service Center area

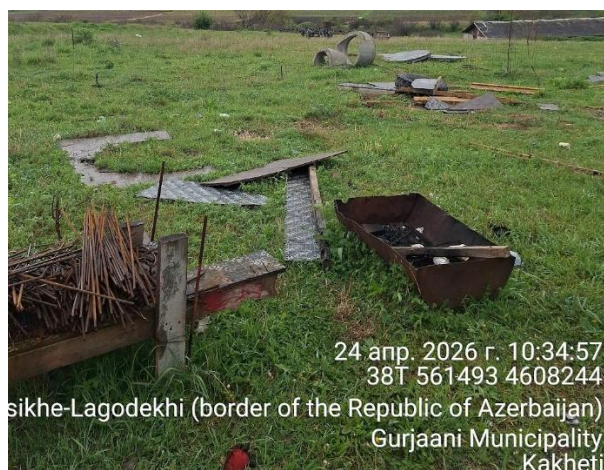
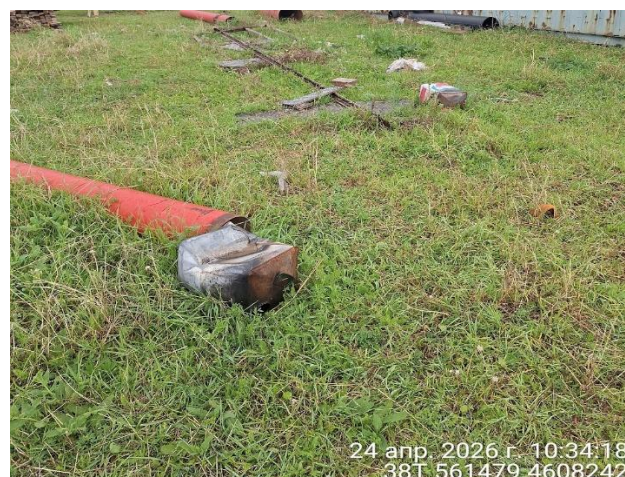
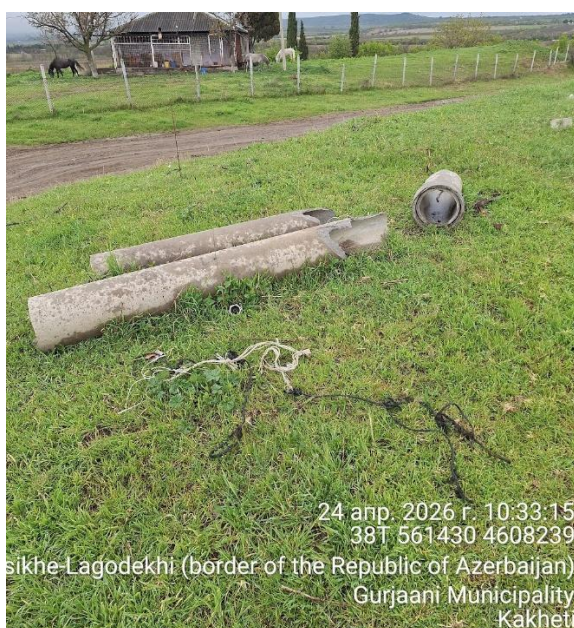
211. Overall, it should be emphasized that while multiple waste streams are present at the site, the total quantitative volume of generated and abandoned waste remains quite small.

Figure 17. Various types of waste in the area of the camp, April 2026

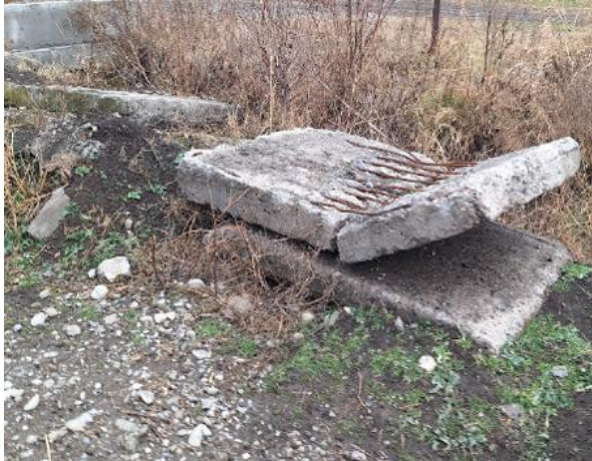
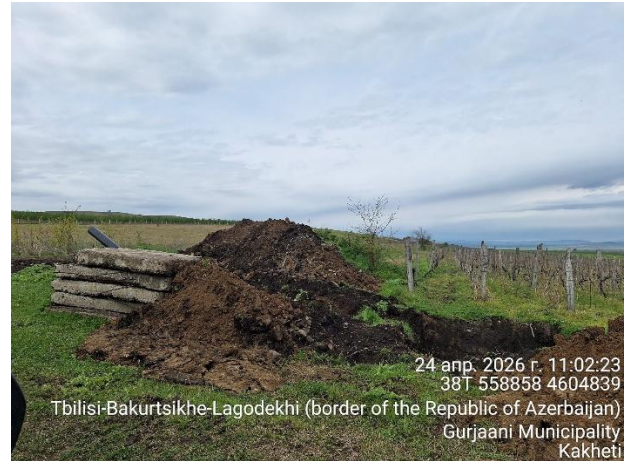
Figure 18. Concrete waste in various areas

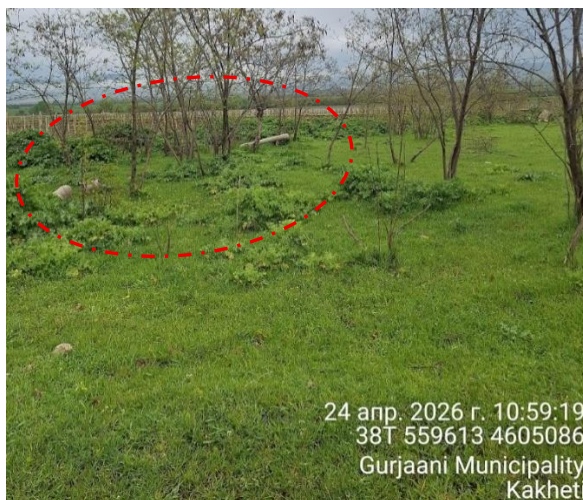
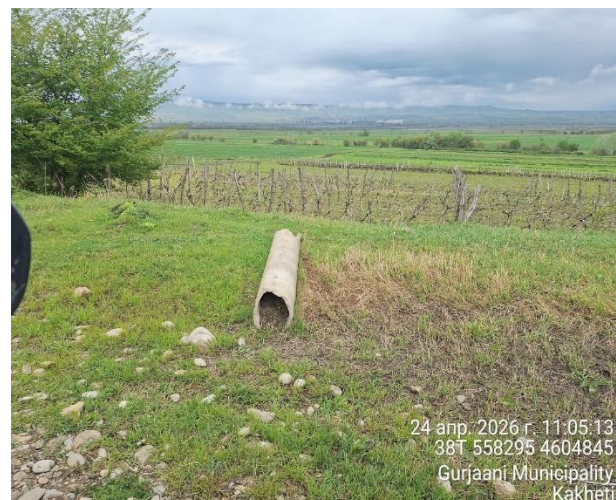
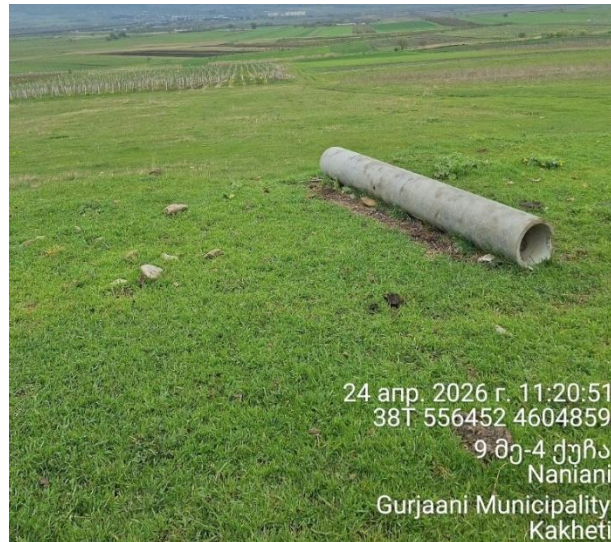
- Waste Management: Significant concerns were identified regarding the legacy of ACM and unmanaged hazardous waste (oil residues) at the abandoned construction camp. No formal agreements for hazardous waste disposal have been verified.

Figure 19. ACM waste in the project area, April 2026

- Site-specific environmental and safety audits to quantify the volume and characteristics of legacy waste, including asbestos-containing materials (ACM), and to assess current site conditions.

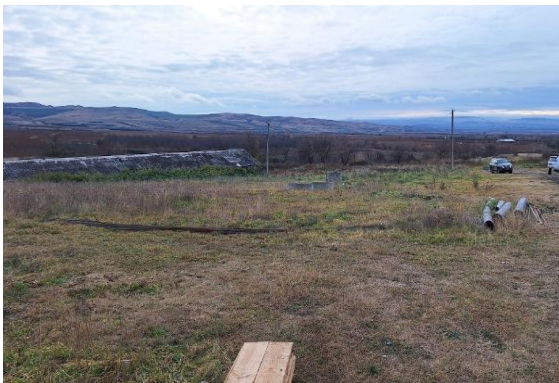
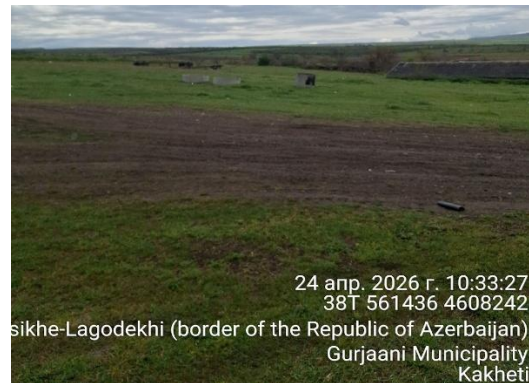
Figure 20. camp site, where various materials are stored without removing the topsoil

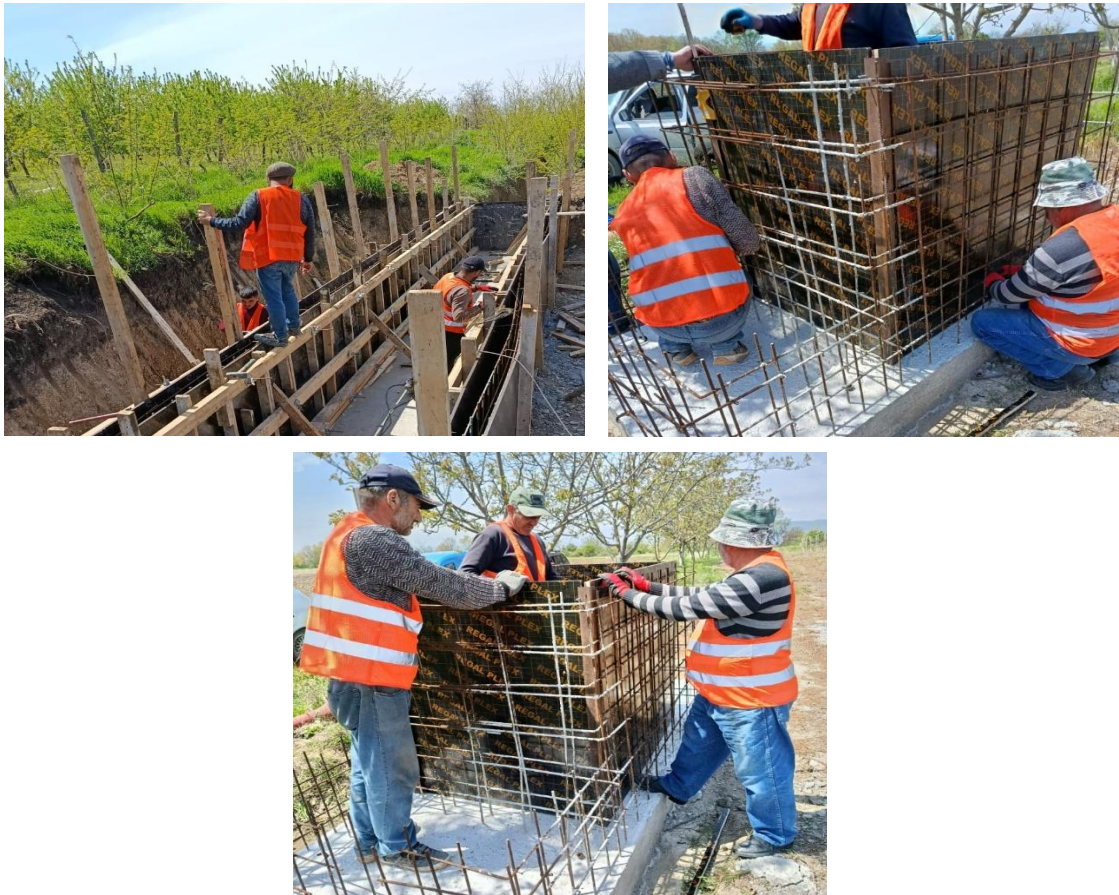
271. Furthermore, during the April 2026 site visit, direct observations of the ongoing minor civil works revealed only partial compliance with PPE requirements. As evidenced by site photos (see figures below), while workers were generally utilizing basic PPE such as high-visibility vests and protective gloves, safety deficiencies were still present. Specifically, workers were observed operating without mandatory hard hats (helmets) and engaging in unsafe practices, such as balancing on narrow wooden formwork over trenches without fall protection.

*Figure 22. Work process and PPE usage practices*

272. Verbal instructions and warnings were immediately issued on-site regarding these violations. Crucially, the execution of these works confirmed the absolute absence of a dedicated, on-site HSE officer to continuously monitor and enforce safety rules.
273. Physically, the field visit showed that the former construction camp is not fenced, and there are no warning or prohibitory signs in the camp area. Although the facility is located away from densely populated areas, there are farms nearby, and the scattered construction waste and open access still may create localized Community Health and Safety risks (e.g., traumatism of livestock or residents). Corrective actions, including site cleanup and access restriction, are required.
