# Environmental Due Diligence Report

Document version: June, 2026

## Georgia: Climate Smart Irrigation Sector Development Program

### Kvemo Samgori Left Main Canal Irrigation Scheme - Areas 5 and 6

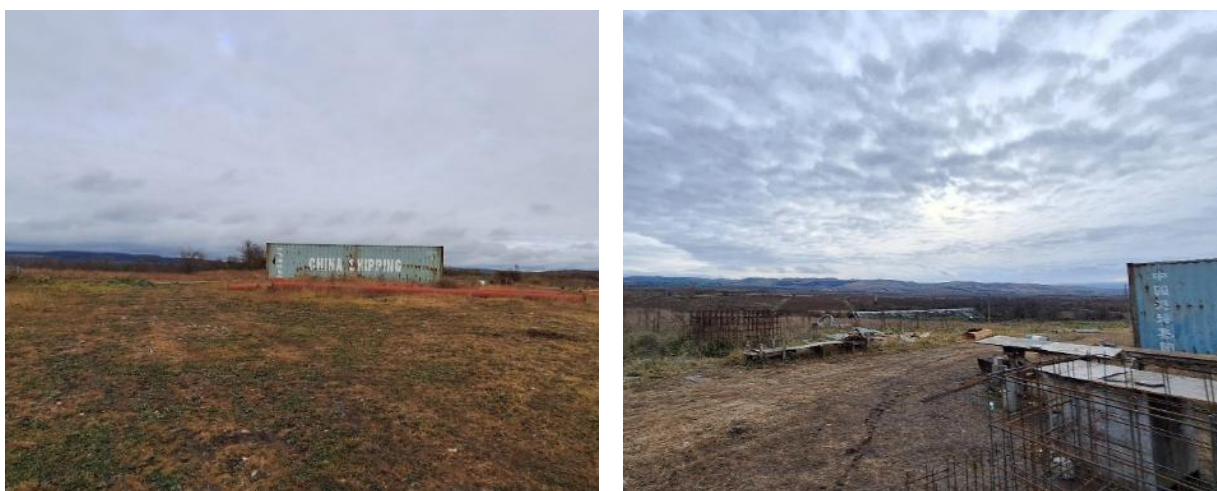
46. During the site visit in December 2025, it was noted that the camp has not been fully demobilized. A storage container, some materials, and waste remained on site.

*Figure 5. View of the Camp area used during rehabilitation (December, 2025)*

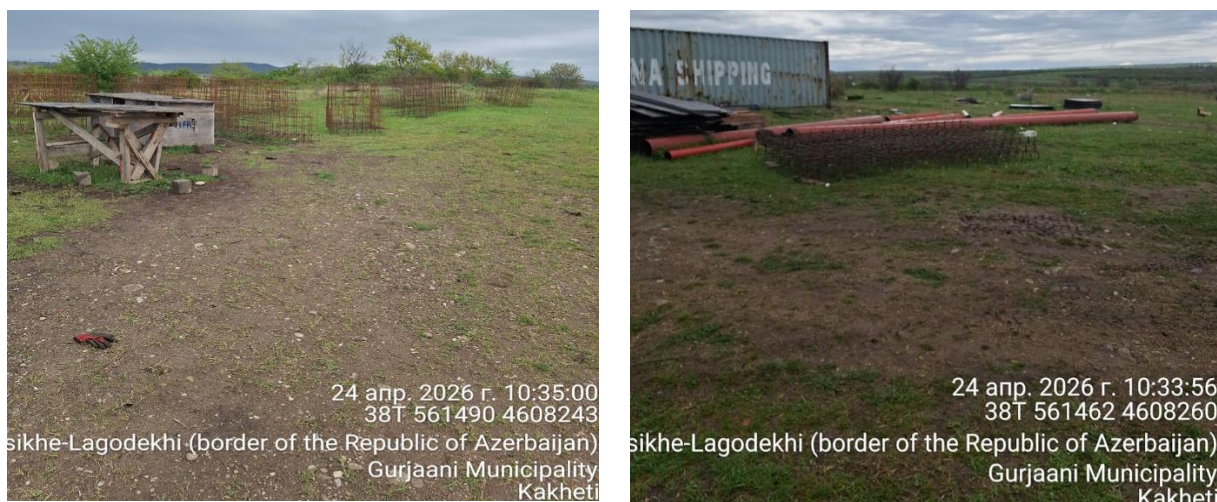
47. Subsequently, the site was rigorously re-inspected during the follow-up field visit on April 24, 2026. It is important to emphasize that no significant changes or improvements were observed between these two visits. Specifically, the area remains unfenced, and the temporary infrastructure has not been updated or expanded. Furthermore, almost no

48. During the April visit, various types of waste were still observed scattered across the camp area (this issue is elaborated upon in detail in the dedicated 'Waste Management' subsection below). Regarding potential soil contamination or oil spills, no significant issues or new spills were observed. In fact, unlike the December visit, the active growth of spring vegetation (grass) in April fully covered the site, and no visible signs of hydrocarbon contamination or recent leaks were detected on the ground.
49. Comparative general views of the area used for the camp during both the December 2025 and April 2026 field visits are shown below.

*Figure 6. View of the Camp area used during rehabilitation (April, 2026)*

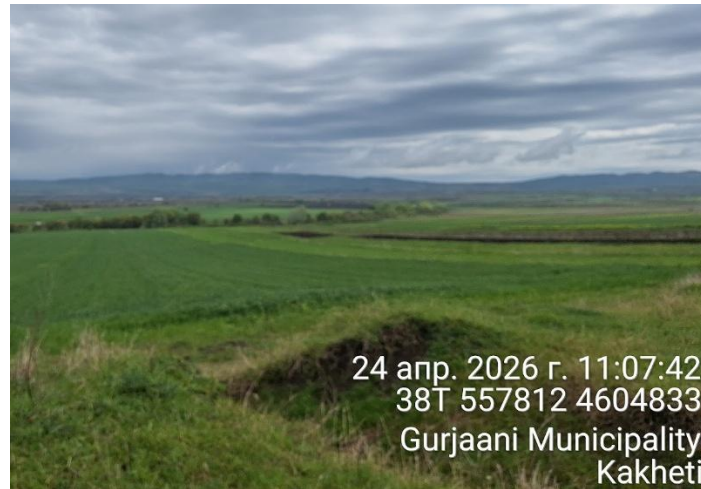
104. During the follow-up field visit - April 24, 2026, a significant socio-environmental issue was documented. Due to the severely degraded and fragmented state of the existing open concrete canals, local farmers frequently resort to unauthorized, improvised water extraction. They manually excavate artificial dirt trenches to divert irrigation water directly to their plots.

105. This unregulated practice is causing severe secondary impacts: It further physically damages the already compromised concrete structure of the G-42 distributor, localized flooding washes out and degrades adjacent unpaved rural roads, and it fosters a highly unsystematic and unequal distribution of water resources among the community.

*Figure 12. Unauthorized artificial trench dug by locals, causing damage to the degraded G-42 canal and the adjacent local unpaved road (April, 2026)*

106. The chaotic conditions observed on-site strongly reaffirm the urgent necessity of completing the rehabilitation works. Transitioning the remaining 8-9 km from an obsolete open canal to a modern, closed underground pressurized pipe system will effectively eliminate the possibility of unauthorized physical interventions. This modernization is critical to ensuring equitable water distribution, preventing localized soil erosion, and protecting the local rural road network from continuous water damage.

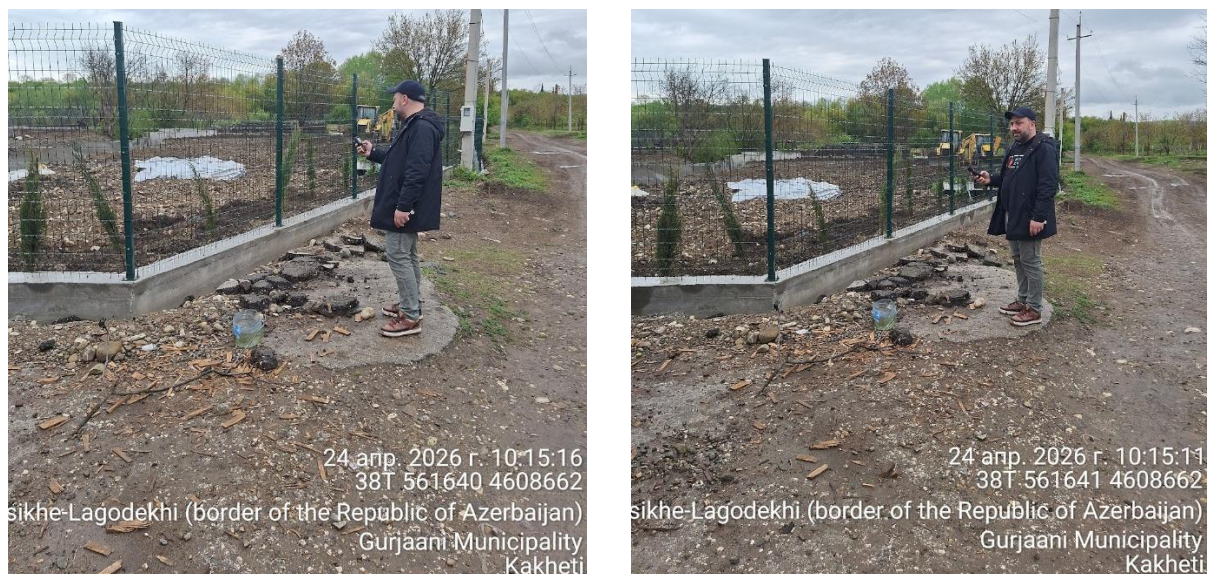
115. Field Screening (April 2026): During the environmental audit on April 24, 2026, preliminary screening measurements for ambient noise were conducted across the project area using a handheld sound level meter. The readings indicated a distinct spatial gradient. Near the newly constructed regional service center in the northern section - adjacent to the main transport corridors - noise levels fluctuated between 50 and 80 dBA, heavily dominated by active traffic. In contrast, within the middle and southern segments of the project corridor, moving towards the Korughi Managed Reserve where the remaining rehabilitation works are pending, the ambient noise was significantly lower and more natural, ranging strictly between 30 and 50 dBA.

Figure 13. Preliminary ambient noise screening conducted near the regional service center (April 24, 2026)

116. Future Baseline Verification Strategy: While these initial April measurements provide a useful general profile of the acoustic environment, they are considered indicative screening tools rather than a formal safeguard baseline. Therefore, to ensure full compliance with ADB SPS requirements and to establish an unimpeachable legal baseline for the contractor, a comprehensive instrumental monitoring campaign will be executed.

117. A certified environmental laboratory utilizing strictly calibrated, certified equipment will be commissioned. They will conduct targeted measurements for daytime ambient noise, localized vibration, and critical air quality parameters (specifically Particulate Matter: PM10 and PM2.5). These formal baseline measurements will be strategically concentrated in the southern coordinates of the command area, specifically to establish the formal pre-construction conditions for the untouched 8-9 km segment of Area 6 before any civil works or heavy machinery mobilization resumes.

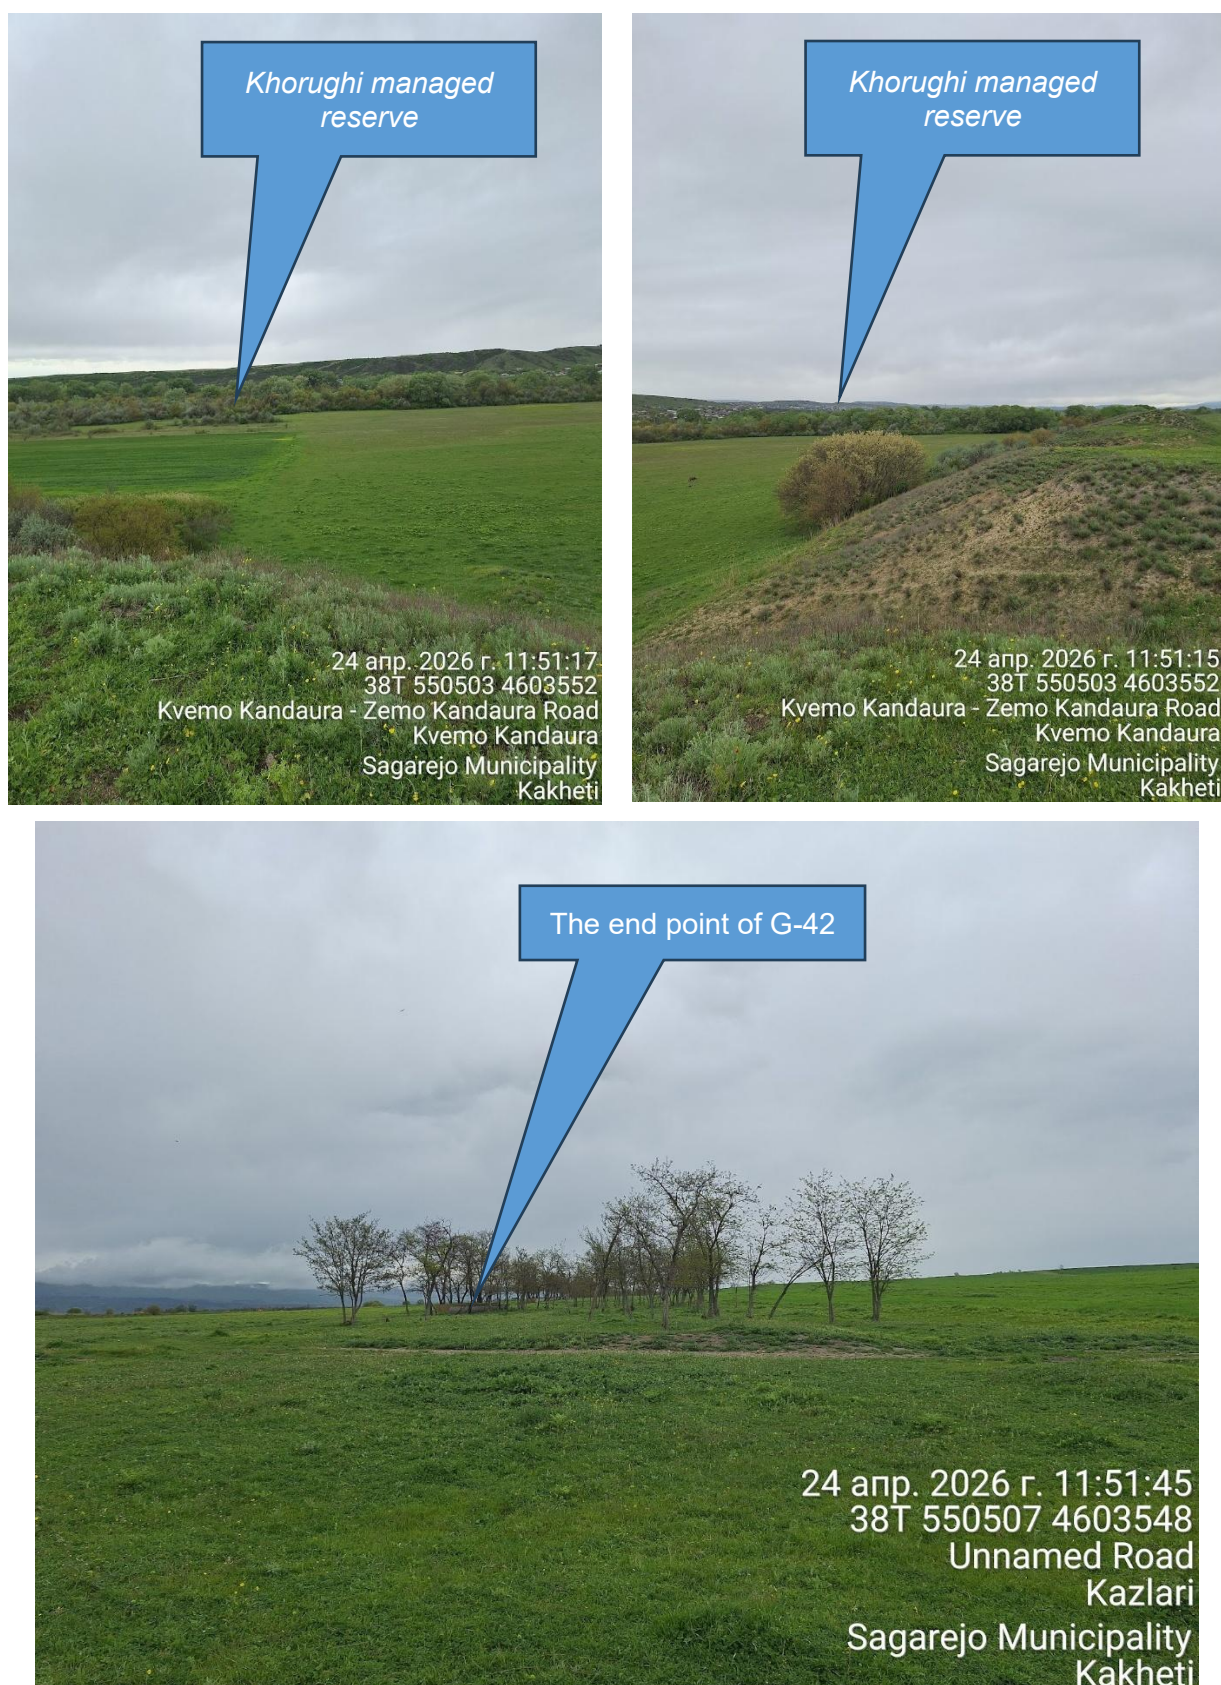
144. Furthermore, no temporary facilities, equipment staging areas, or waste dumps were established near the protected area's boundaries. This sensitive territory remains entirely untouched and completely free from any direct or indirect project-related impacts.

Figure 15. The boundary of the Korughi Managed Reserve interfacing with the untouched, un-rehabilitated segment of the G-42 canal, confirming the absence of construction impacts (April 24, 2026).

145. This pristine status is firmly corroborated by the official spatial KMZ map provided by GA (detailed in Section A) and the coordinate-stamped photographic evidence capturing the un-rehabilitated canal interfacing with the reserve boundary (see Figure 15 above).

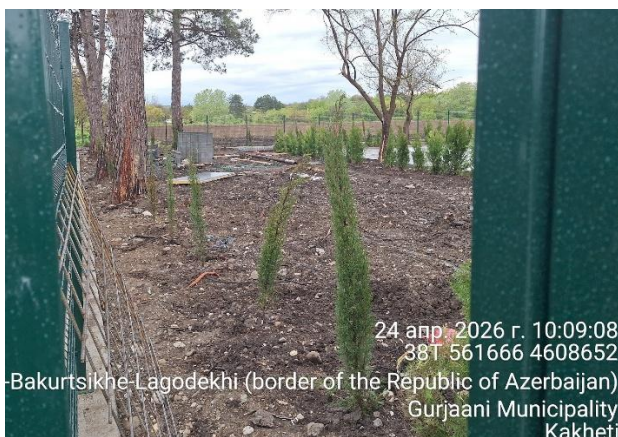
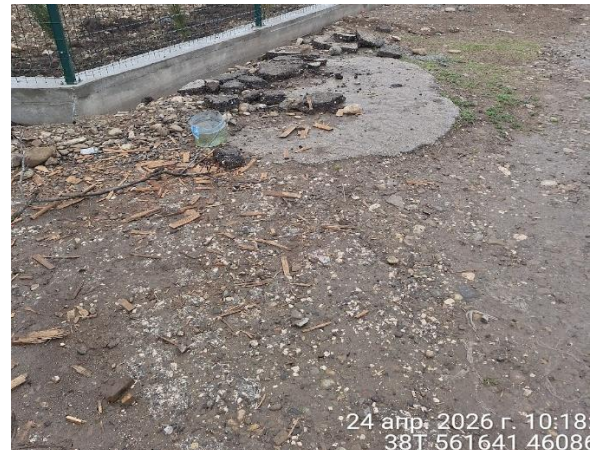
Figure 16. Waste in the new GA Service Center area

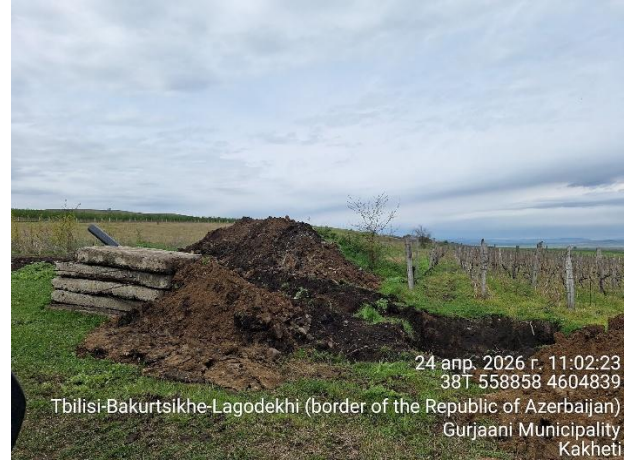
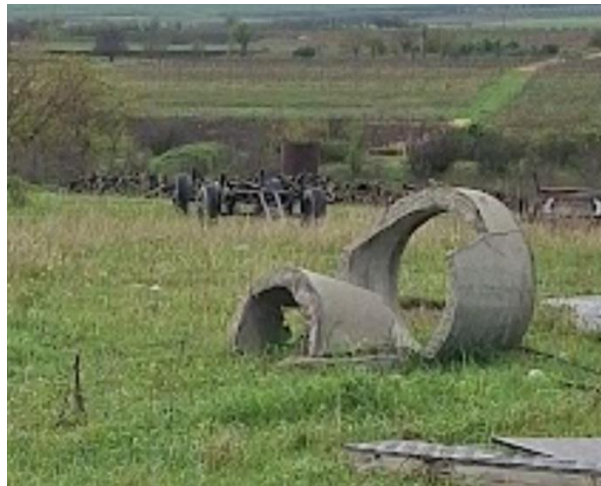
Figure 18. Concrete waste in various areas

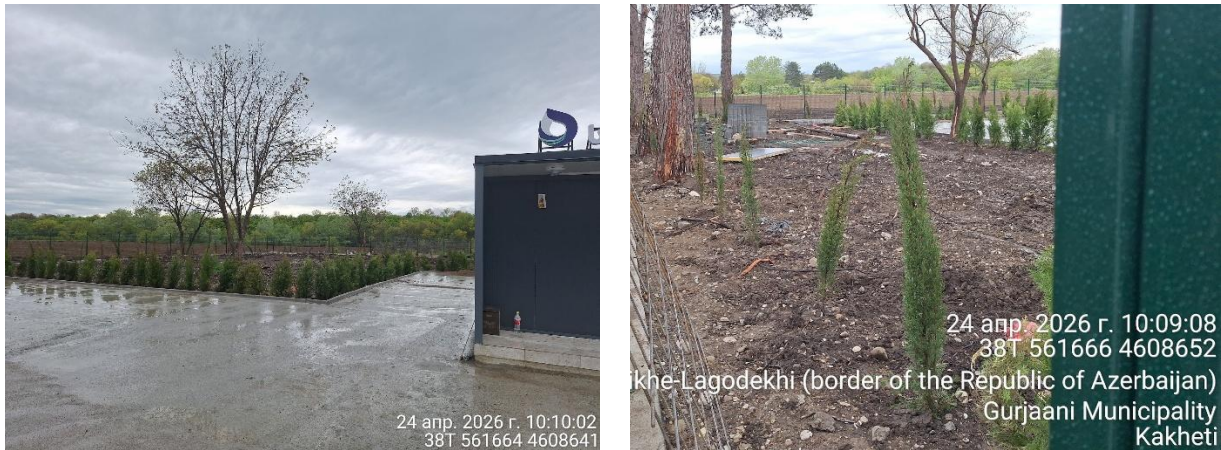
262. Furthermore, it is a highly positive development that the yard of the new building has been landscaped with newly planted trees and vegetation (see figures below). Given its immediate proximity to the public road, this greening effort will generate a significant, long-term positive visual and landscape effect. While these aspects are commendable, the presence of scattered construction waste within its perimeter currently creates a temporarily unfavorable visual and sanitary condition.

*Figure 21. Planting and landscaping works at the new GA building*

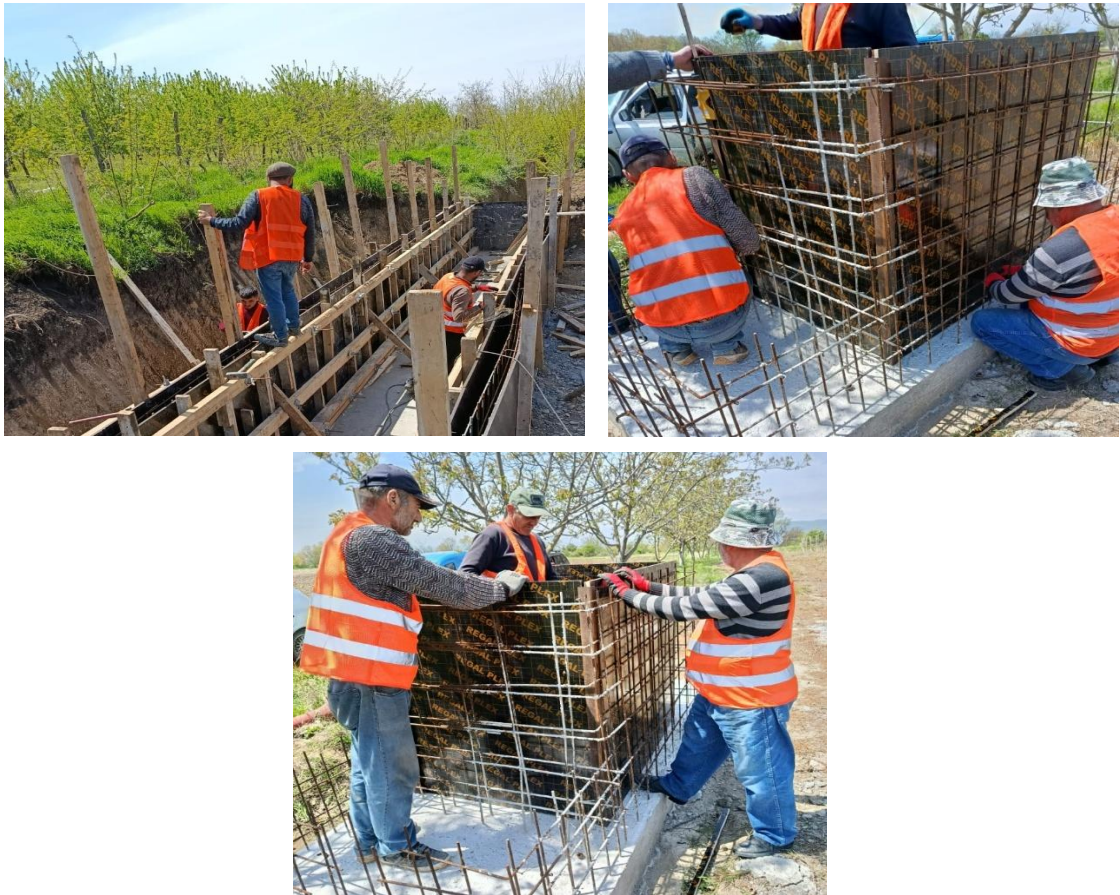
271. Furthermore, during the April 2026 site visit, direct observations of the ongoing minor civil works revealed only partial compliance with PPE requirements. As evidenced by site photos (see figures below), while workers were generally utilizing basic PPE such as high-visibility vests and protective gloves, safety deficiencies were still present. Specifically, workers were observed operating without mandatory hard hats (helmets) and engaging in unsafe practices, such as balancing on narrow wooden formwork over trenches without fall protection.

*Figure 22. Work process and PPE usage practices*

272. Verbal instructions and warnings were immediately issued on-site regarding these violations. Crucially, the execution of these works confirmed the absolute absence of a dedicated, on-site HSE officer to continuously monitor and enforce safety rules.
273. Physically, the field visit showed that the former construction camp is not fenced, and there are no warning or prohibitory signs in the camp area. Although the facility is located away from densely populated areas, there are farms nearby, and the scattered construction waste and open access still may create localized Community Health and Safety risks (e.g., traumatism of livestock or residents). Corrective actions, including site cleanup and access restriction, are required.
