**Geotechnical survey for Feasibility Studies and Preliminary Design for the Open Programme Extension of Transmission Network II.
OHL Tskhaltubo-Akhaltzikhe; Akhaltzikhe-Tortum**

Table of Contents

Explanatory letter

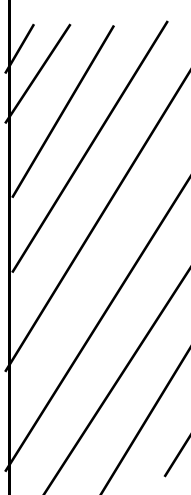
Borehole AS 1

Sam. №1 3.20-3.50	Light brown hard-plastic consistency clay

The land plot allocated for the electric power transmission line mast is located in Tskaltubo Municipality, in particular on the nearby territory of the electric Substation. The territory is characterized with a hilly relief. While the visual inspection of the plot the trace of the landslide or other negative physical-geological processes had not been observed.

1) AS 1B (Borehole #1) – is arranged on the land plot allocated for the electric power transmission line mast, located in Tskaltubo Municipality, in particular on the nearby territory of the electric Substation „Tskhaltubo 500 kv“ under construction. The territory is characterized with satisfactory conditions for the construction the electric transmission mast. In the borehole on the depth from 0.00 m to 6.30 m the light brown hard-plastic consistency clay is been detected.

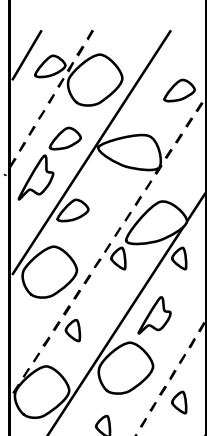
nim. #1 3.60- 4.30	Crushed stones of andesite basalts with insertions of medium size boulders, with hard-plastic consistency clay filler Crushed stones ≈60%.

The project territory is located in Akhaltzikhe Municipality to the East of the mountain system located to the Northeast of the village Sviri, on the Northeast exposition of the slope with the inclination ≈10-15°. The landslide or any other negative geodynamic processes are not observed. The surrounding area is stable.

20) AS 23T (Borehole #23) - The project territory is located in Akhaltsikhe Municipality to the East of the mountain system located to the Northeast of the village Sviri, on the Northeast exposition of the slope with the inclination ≈10-15°. The landslide or any other negative geodynamic processes are not observed. The surrounding area is stable.

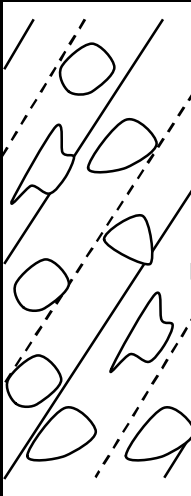
Sam. #1 3.10- 3.30	Andesite basalt boulder place with semi-solid consistency clay filler. Filler ≈10%

The project area is located to the North of Akhaltsikhe town. The point to be assessed is located to the Southwest of the existing mast in ≈30 m. on the andesite basalt boulder hill with sharply inclined (≈60°) slope. The place is stable, negative geodynamic processes are not observed.

31) AT 18T (Borehole #18) – The project area is located to the North of Akhaltsikhe town. The point to be assessed is located to the Southwest of the existing mast in ≈30 m. on the andesite basalt boulder hill with sharply inclined (≈60°) slope. The place is stable, negative geodynamic processes are not observed

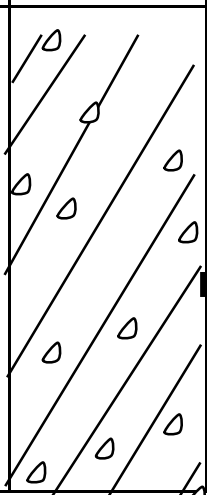
Sam. 1 3.10-3.30	Light brown hard plastic consistency clay loam with up to 10% small inclusions of thin fragments of Andesite-basalt

The territory is located in Akhaltsikhe Municipality on the left bank of the river Potskhovi. The relief is a slope with a small inclination ($\approx 5-10\%$) at the existing masts. The territory is stable, no landslides or other negative geological processes had been observed.

33) AT 25T (Borehole #25) – The territory is located in Akhaltsikhe Municipality on the left bank of the river Potskhovi. The relief is a slope with a small inclination (≈5-10%) at the existing masts. The territory is stable, no landslides or other negative geological processes had been observed.
