# Environmental Due Diligence Report

Document version: June, 2026

## Georgia: Climate Smart Irrigation Sector Development Program

### Kvemo Samgori Left Main Canal Irrigation Scheme - Areas 5 and 6

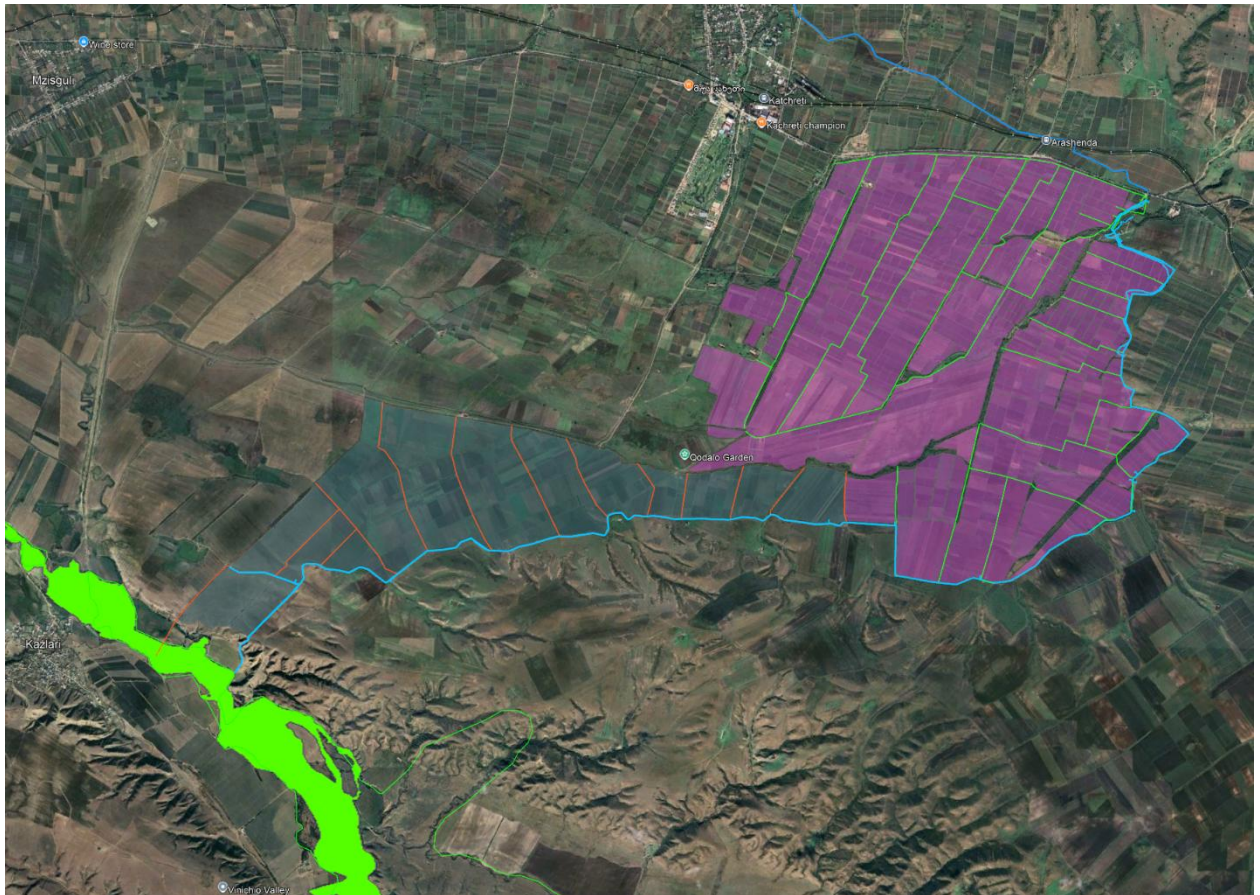
Figure 4. Spatial distribution of rehabilitation works. Pink: Completed areas; Blue/Grey: Untouched 8-9 km segment of Area 6; Green: Korughi Managed Reserve (Source: GA KMZ data, May 20, 2026)

- iii. **Untouched Section (Remaining 8-9 km) and Environmental Significance:** Approximately 8 to 9 km of the G-42 canal remains untouched, and no rehabilitation works are currently underway in this section. Importantly, this remaining segment is the closest to the Korughi Managed Reserve boundary. Based on the latest spatial data (KMZ files) officially provided in GA's May 20, 2026 clarification letter, a precise delineation of the work footprint has been established. As illustrated in Figure X below, the areas shaded in pink represent the completed rehabilitation zones (encompassing Area 5 and the northern portion of Area 6). The blue/grey polygon highlights the remaining, untouched 8-9 km segment of the G-42 distributor. Crucially, the bright green polygon delineates the official boundaries of the Korughi Managed Reserve.

38. This mapping officially confirms the most significant environmental finding of this audit: no rehabilitation works have yet been executed in the most ecologically sensitive segment of the project area - the southern periphery directly adjacent to the Korughi Managed Reserve. This spatial data perfectly corroborates the findings of the April 24, 2026 field visit, which, supported by date- and coordinate-stamped photo-evidence, visually confirmed that no construction interventions have occurred in this sensitive area so far. Furthermore, the absence of any prior construction activities in this vicinity was corroborated during our consultations with the Korughi Managed Reserve Administration. To formally substantiate these field observations and verbal confirmations, an official written request has been submitted to APA to confirm that no construction works have been executed within or in the immediate vicinity of the protected area boundaries. The

39. This is a highly positive finding, as it ensures that any future rehabilitation activities in this segment will be planned and executed strictly under the regulatory framework and safeguard requirements of the ADB. This guarantees the implementation of rigorous pre-construction biological surveys, strict exclusion and buffer zone management, proper hazardous waste handling protocols, and continuous ecological monitoring. Such stringent international safeguards will effectively eliminate the risk of accidental encroachment or indirect impacts on the Korughi Reserve's unique ecosystems—protections that might be less rigorously enforced under standard local construction practices. (This issue is discussed in greater detail in the dedicated Protected Areas section of this report).

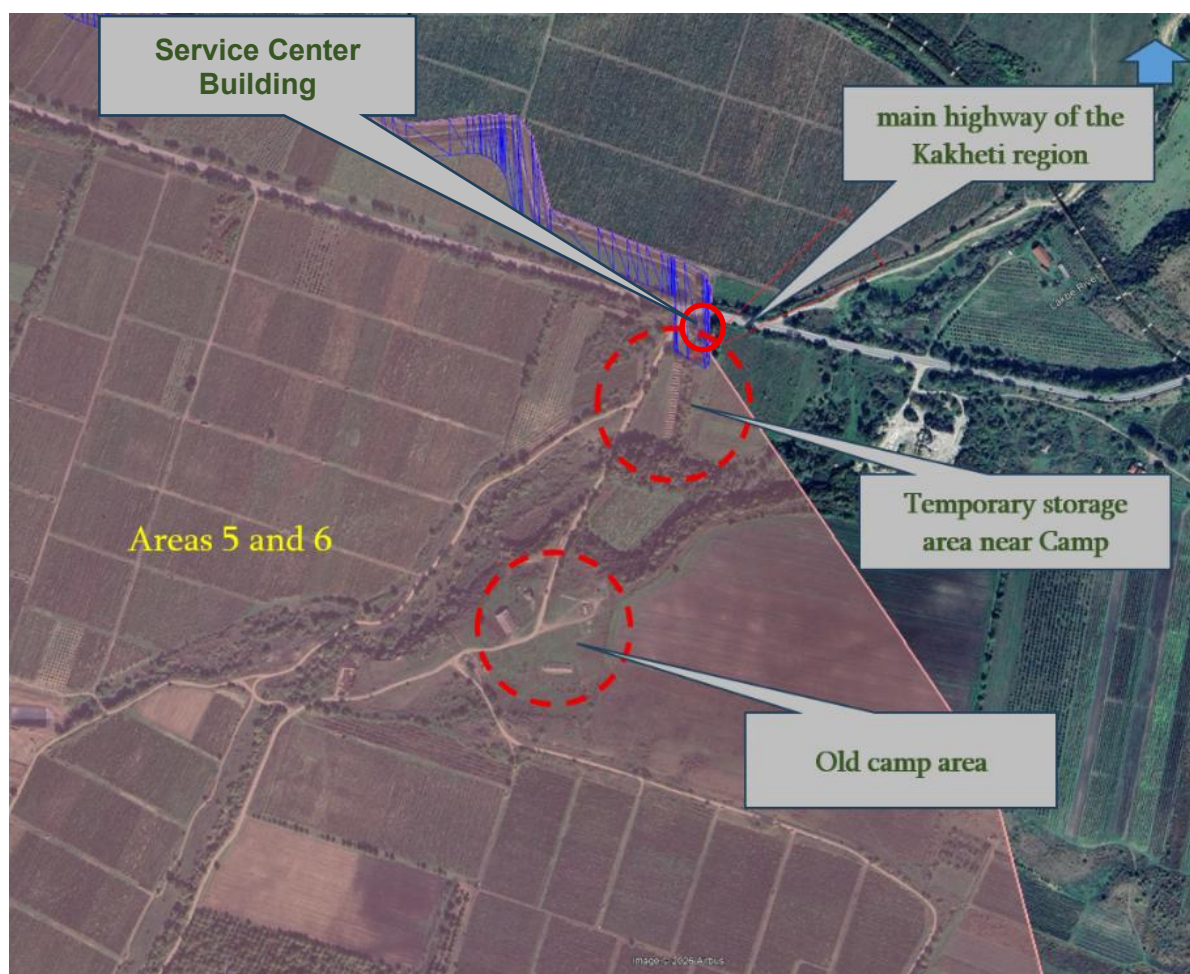
Figure 10. Location of the old camp, concrete slabs storage area and new service center building

46. During the site visit in December 2025, it was noted that the camp has not been fully demobilized. A storage container, some materials, and waste remained on site.

47. Subsequently, the site was rigorously re-inspected during the follow-up field visit on April 24, 2026. It is important to emphasize that no significant changes or improvements were observed between these two visits. Specifically, the area remains unfenced, and the temporary infrastructure has not been updated or expanded. Furthermore, almost no

48. During the April visit, various types of waste were still observed scattered across the camp area (this issue is elaborated upon in detail in the dedicated 'Waste Management' subsection below). Regarding potential soil contamination or oil spills, no significant issues or new spills were observed. In fact, unlike the December visit, the active growth of spring vegetation (grass) in April fully covered the site, and no visible signs of hydrocarbon contamination or recent leaks were detected on the ground.
49. Comparative general views of the area used for the camp during both the December 2025 and April 2026 field visits are shown below.

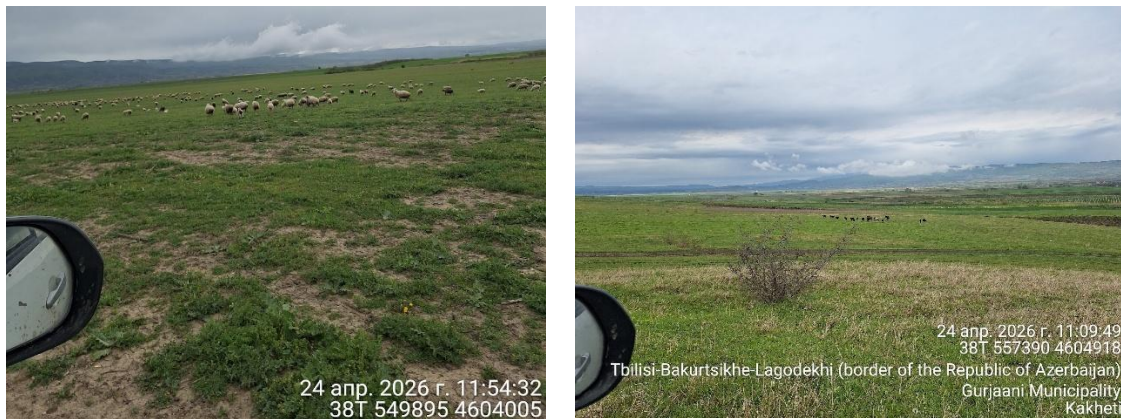
*Figure 11. Typical grazing activities near the southern peripheries of the project area*

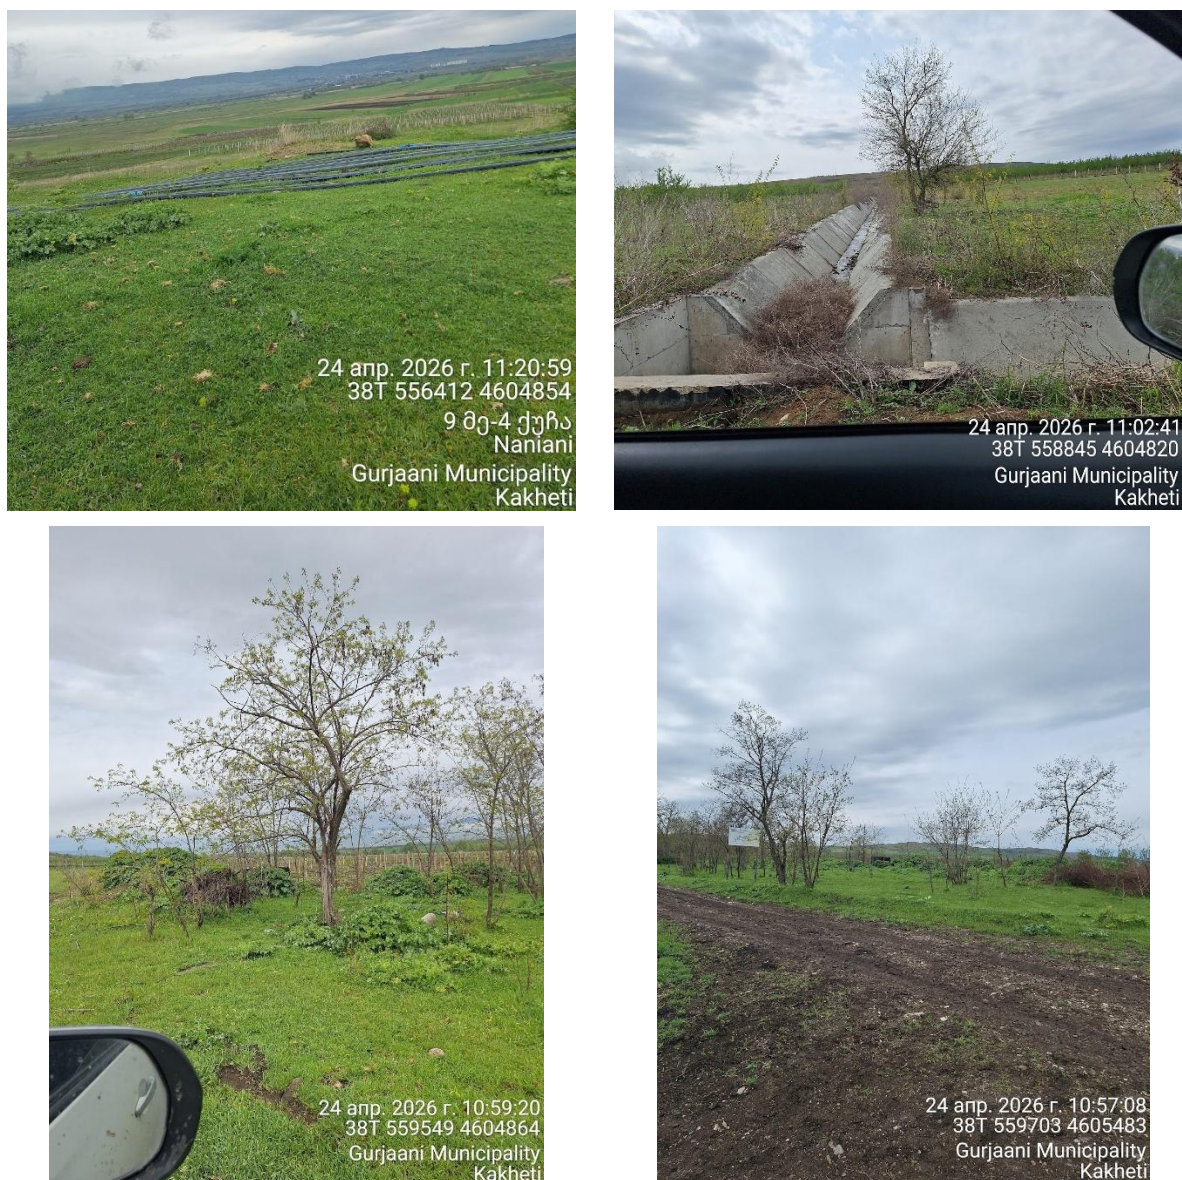
124. Overall, it can be concluded that the project corridor contains low-value habitats—a heavily disturbed mosaic of agricultural fields and degraded secondary forest fragments. The anthropogenic impact on the original vegetation cover is quite significant, ensuring that civil works within the established RoW will not cause meaningful loss of native biodiversity.

Figure 14. Typical highly modified agricultural habitats (vineyards and arable lands) and low-value secondary vegetation dominating the project corridor

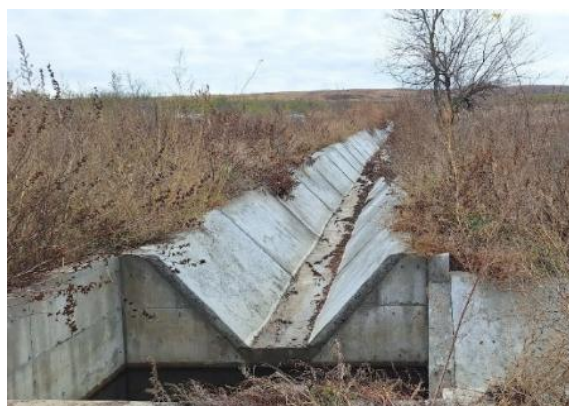
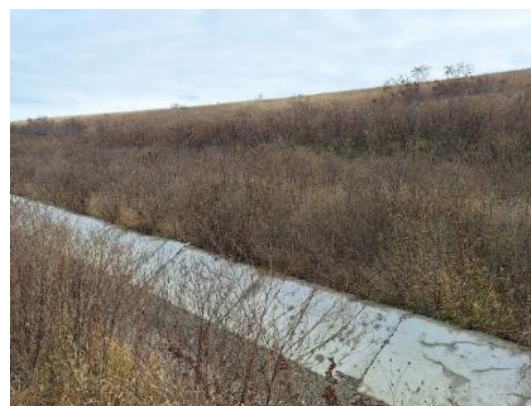
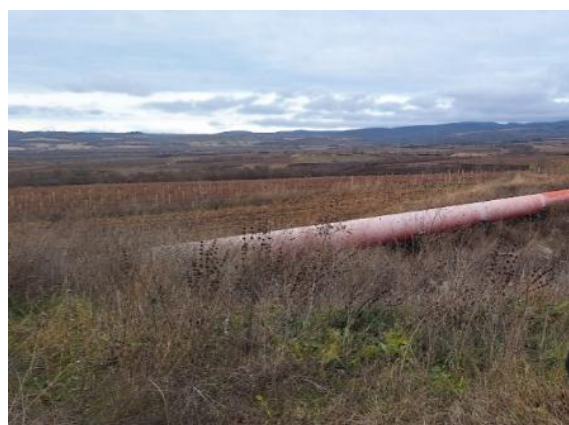
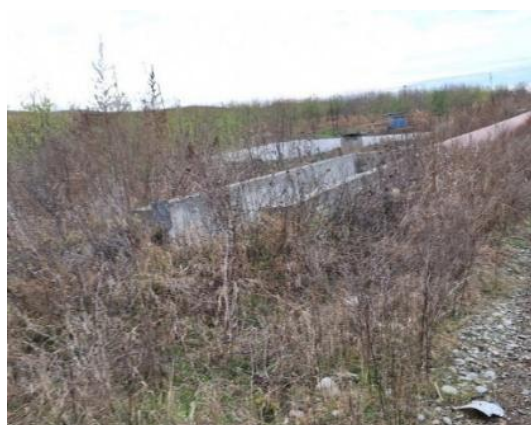
**Condition of the irrigation system of Areas 5 and 6 after rehabilitation (December, 2025)**
