# Environmental Due Diligence Report

Document version: June, 2026

## Georgia: Climate Smart Irrigation Sector Development Program

### Kvemo Samgori Left Main Canal Irrigation Scheme - Areas 5 and 6

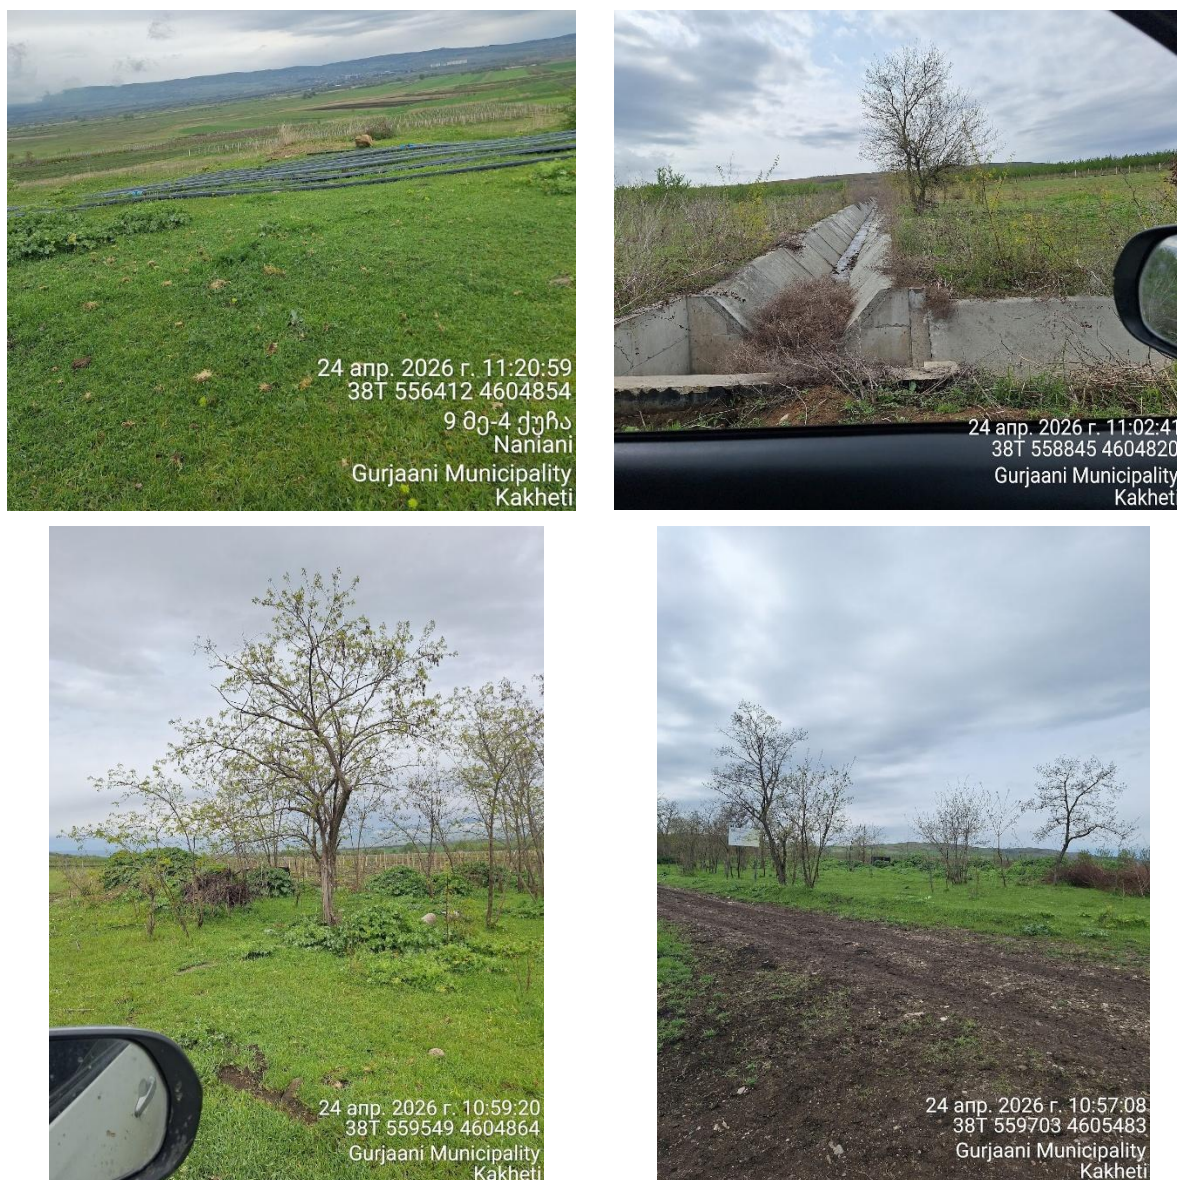
124. Overall, it can be concluded that the project corridor contains low-value habitats—a heavily disturbed mosaic of agricultural fields and degraded secondary forest fragments. The anthropogenic impact on the original vegetation cover is quite significant, ensuring that civil works within the established RoW will not cause meaningful loss of native biodiversity.

Figure 14. Typical highly modified agricultural habitats (vineyards and arable lands) and low-value secondary vegetation dominating the project corridor

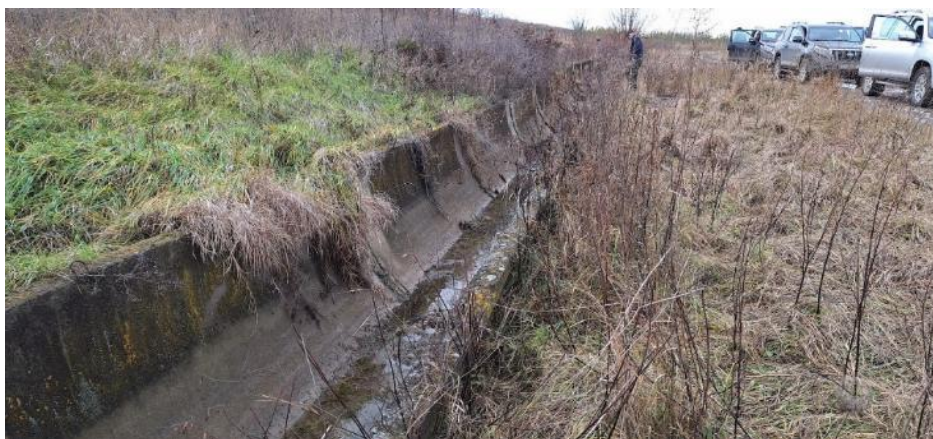
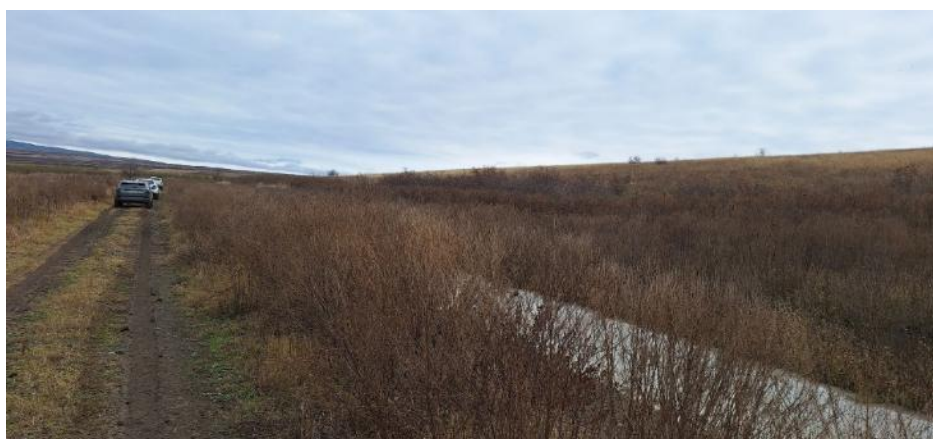
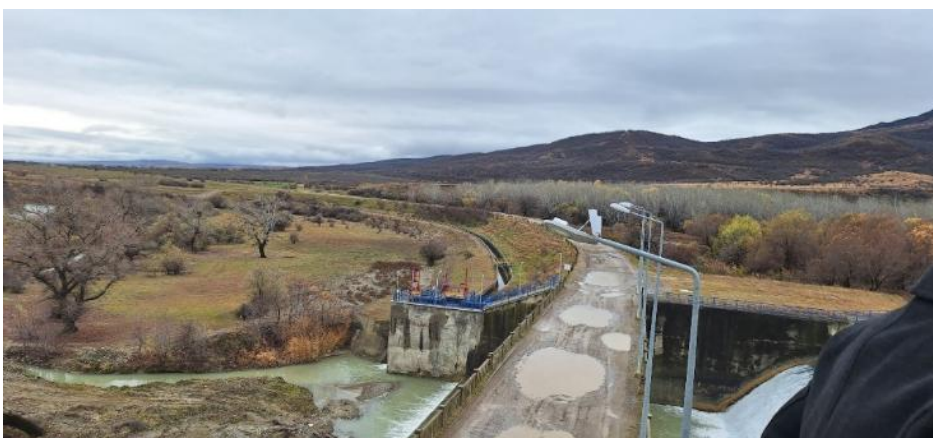
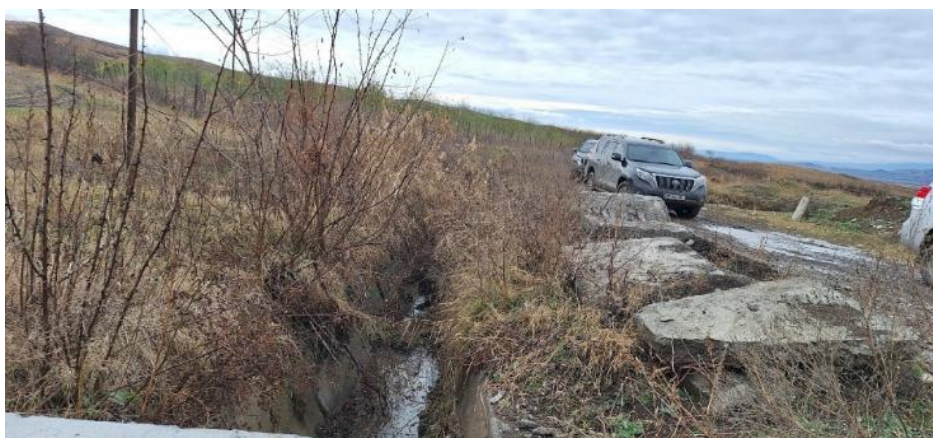
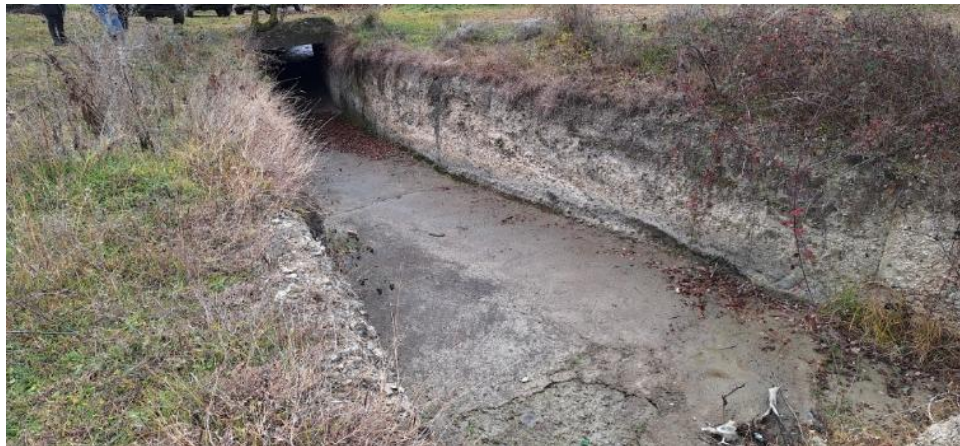
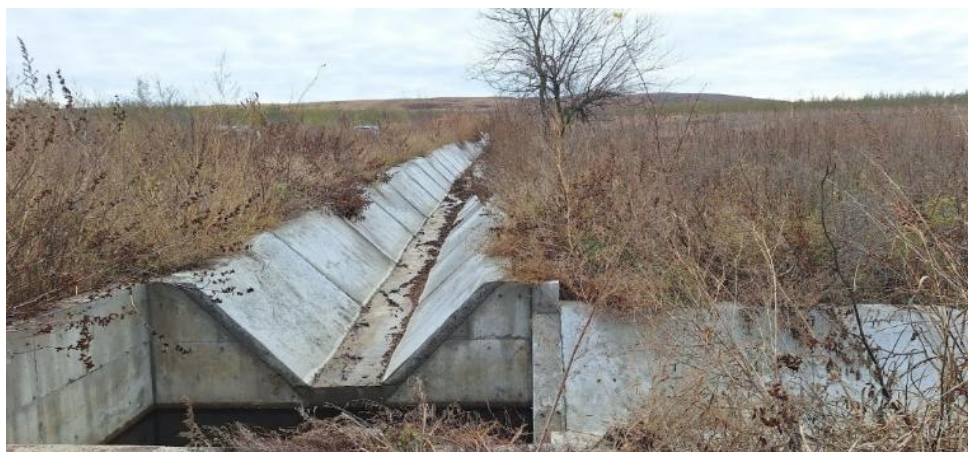
**Annex 8. Areas 5 and 6 site visit in 10 December 2025**

46. During the site visit in December 2025, it was noted that the camp has not been fully demobilized. A storage container, some materials, and waste remained on site.

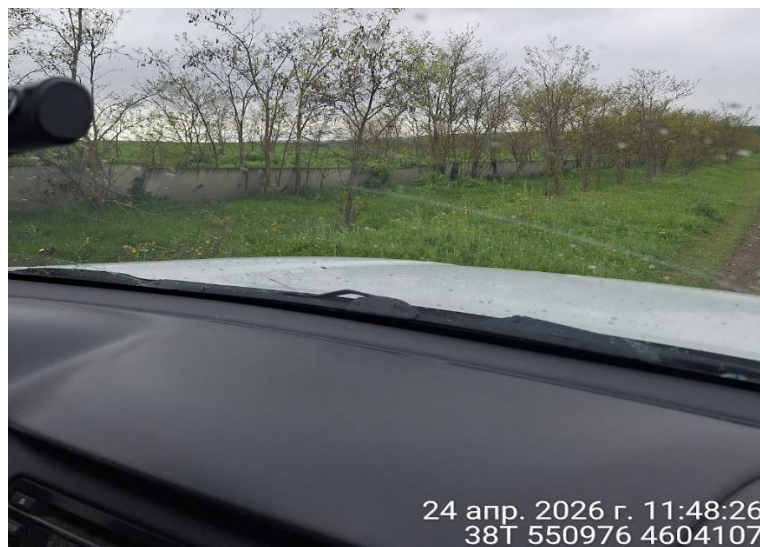
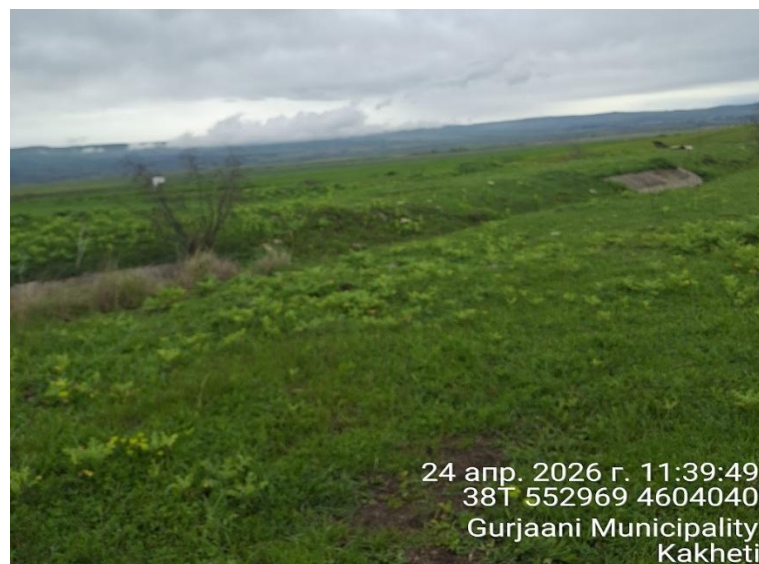
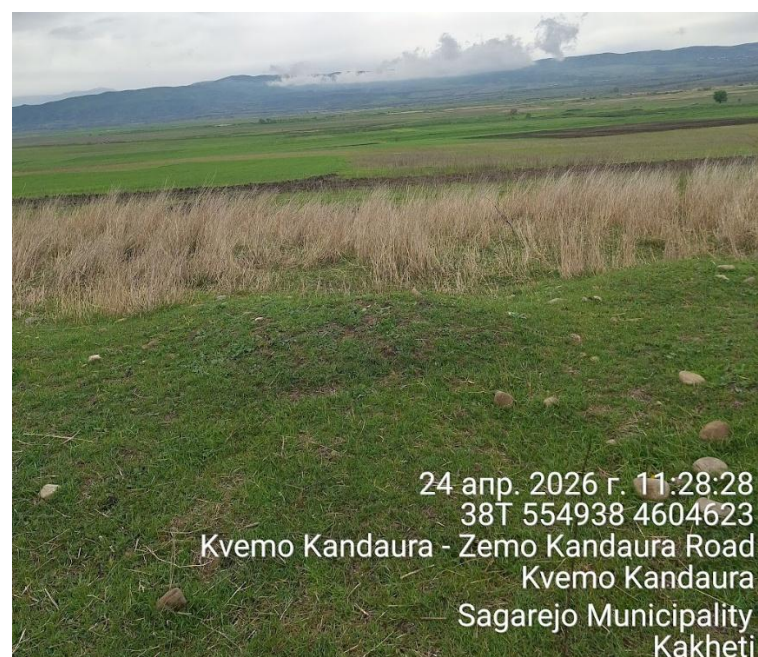
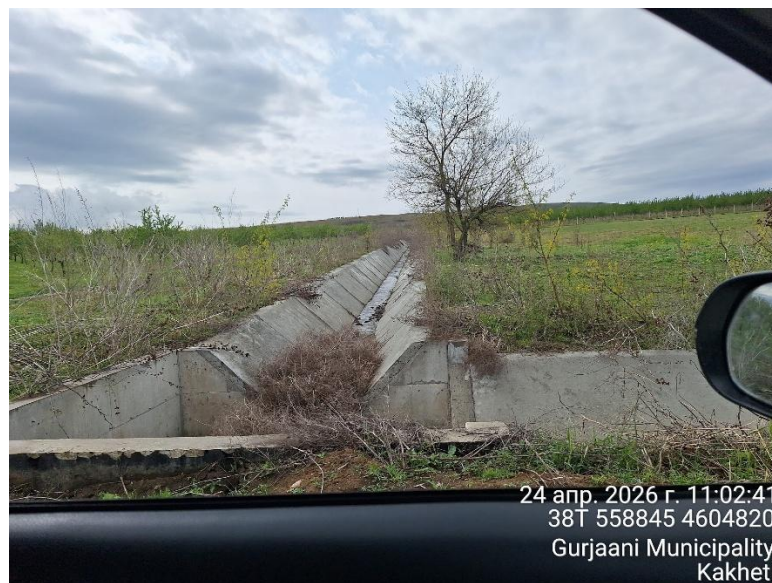
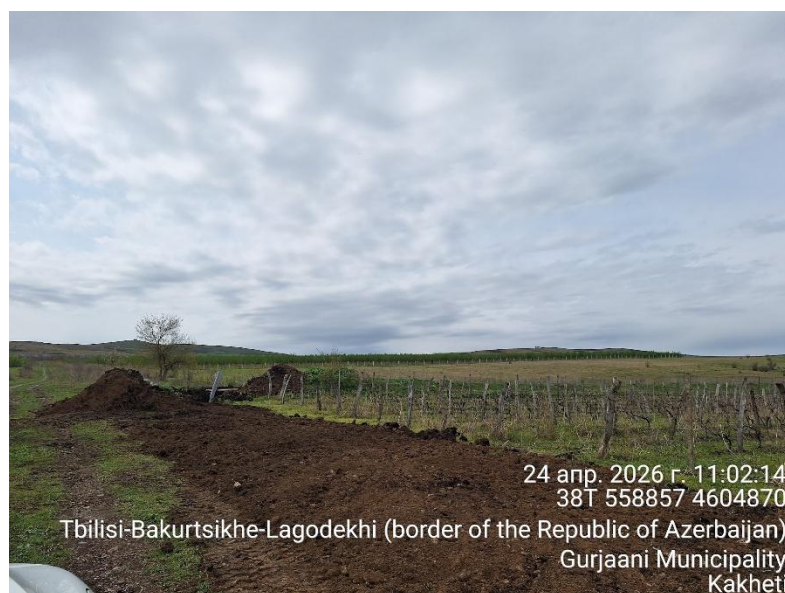
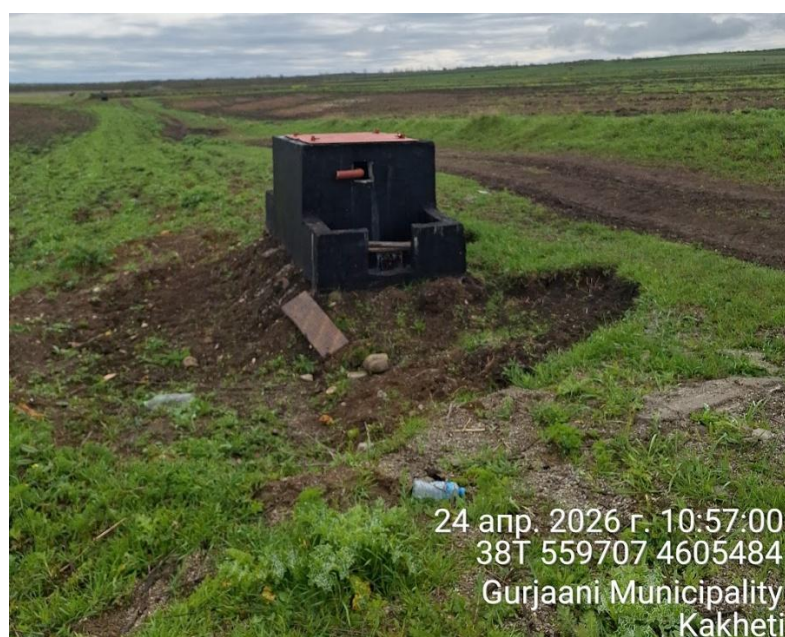
**Annex 9.** Areas 5 and 6 site visit in 24 April 2026

47. Subsequently, the site was rigorously re-inspected during the follow-up field visit on April 24, 2026. It is important to emphasize that no significant changes or improvements were observed between these two visits. Specifically, the area remains unfenced, and the temporary infrastructure has not been updated or expanded. Furthermore, almost no

48. During the April visit, various types of waste were still observed scattered across the camp area (this issue is elaborated upon in detail in the dedicated 'Waste Management' subsection below). Regarding potential soil contamination or oil spills, no significant issues or new spills were observed. In fact, unlike the December visit, the active growth of spring vegetation (grass) in April fully covered the site, and no visible signs of hydrocarbon contamination or recent leaks were detected on the ground.
49. Comparative general views of the area used for the camp during both the December 2025 and April 2026 field visits are shown below.

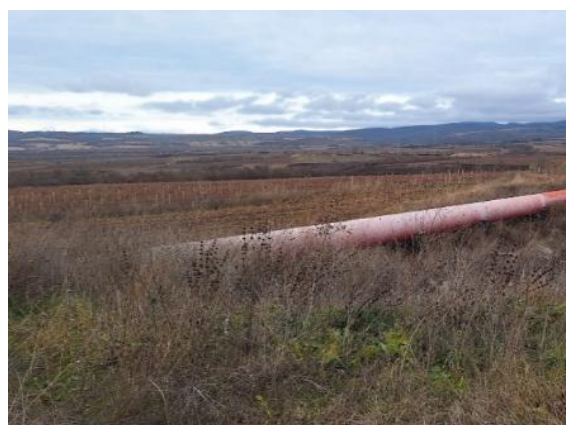
**Condition of the irrigation system of Areas 5 and 6 after rehabilitation (December, 2025)**
