Draft Initial Environmental Examination

Georgia: Climate Smart Irrigation Sector Development Program

Kvemo Samgori Left Main Canal Irrigation Scheme – Package 1: Main Canal Ch 313+42 to Ch 397+00 and Package 2: Area 1 – Irrigation area G 23 to G 33

Prepared by the Ministry of Environmental Protection and Agriculture, Government of Georgia for the Asian Development Bank.

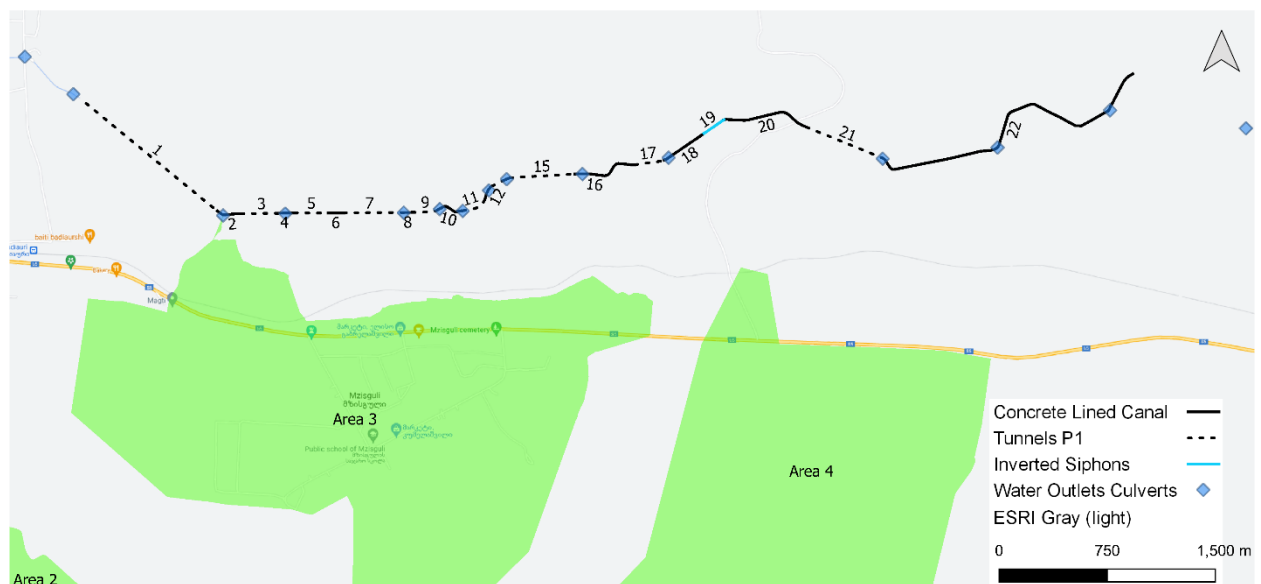
Figure 5: Package 1 - Main Canal Features¹⁴

49. The main canal is 8358 m (Pk. 313 + 42 ÷ Pk. 397 + 00), comprising of 3,938.7m open trapezoidal canals, 309m rectangular canal, 9 tunnels (3,623m), inverted siphons (440.3m) and a spillway (47m), Figure 5. The tunnels range in size from 96 to 4,104m with a width of 3.0 to 3.3m and a height of 3.0 to 3.2m. All tunnels need to be cleared of sediment.

- c. Water inlet of the pumping station with no sluice gate.
 - d. Three culvert water outlets for distribution branches G39, GI and GII. G39 is a hole drilled into the galley and the pipe is made out of asbestos, GI is a channel that is sedimented, the wall needs plastering but the sluice gate is in working order, and GII is a steel pipe without a sluice gate and is sedimented.

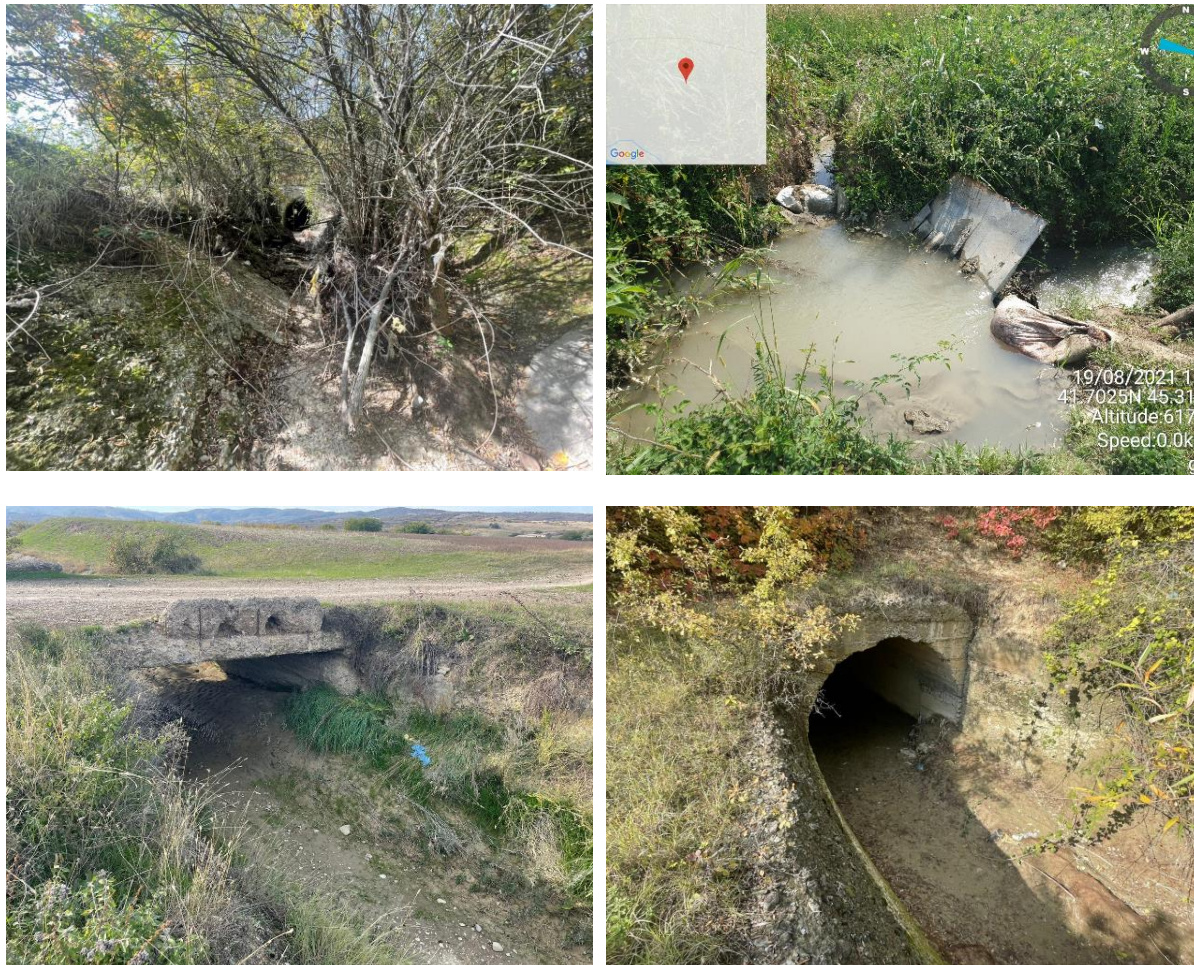
Figure 6: Condition of the Main Canal¹⁵

1. Tunnel inlet has already been rehabilitated but the outlet walls and arch are eroded. This is 2m by 1.9m.
2. Canal is a trapezoidal canal lined with monolithic concrete. The lining is damaged on the sides and the bottom is defected with holes.

3. Tunnel walls and ceiling are eroded.
4. Canal is a trapezoidal canal lined with monolithic concrete. The side has collapsed in places and damaged in others, the bottom is also damaged

16. Canal is a trapezoidal canal lined with monolithic concrete. The lining is damaged, overgrown and sedimented. The left slope is damaged in places and the right slope needs to be replaced in places. The canal is overgrown by 15 trees over 30cm in diameter.

48. The main open canals are in poor condition with encroached vegetation, blockages due to sediment and other debris build-up, sides of the canal cracking and collapsing and the lining of the tunnel is eroded. This main canal will need to be cleared, cleaned, repaired or replaced, cleaning, repairs of other structural units, improvements to the access road and repairs and improvements of overpasses and bridges.

52. Main Canal has a detailed design. The main canal should be cleared of sediment, rubble and encroaching vegetation, after this works include:

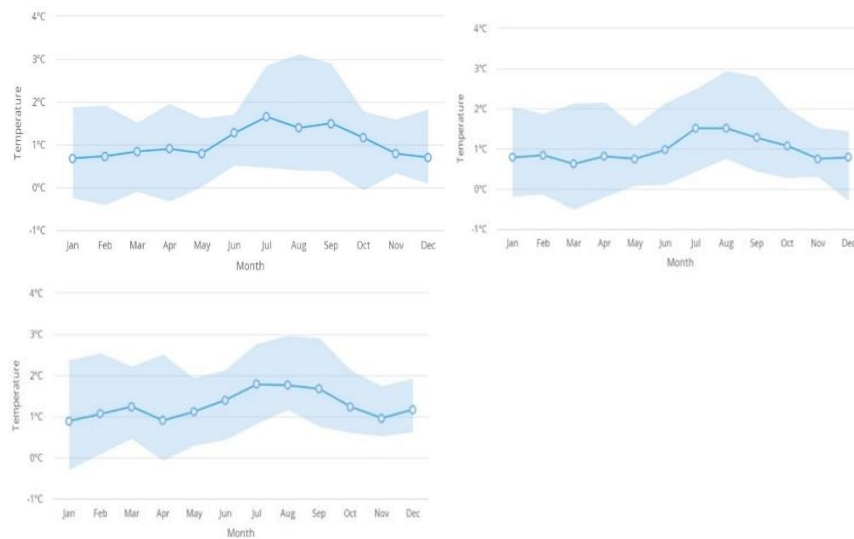
Figure 11: Projected Change in Temperature near Sagarejo between 2020 to 2039, left to right RCP2.6, RCP6 and RCP 8.5

130. **Temperature:** Under the RCP (Representative Concentration Pathways) 2.6 and 4.5, the changes will be manageable. Temperatures under RCP 6.0 and above predict a substantial projected increase from 2080 onwards. Changes in maximum temperature are projected to increase by almost 10 degrees C under RCP 8.6 by 2099. Under the various RCP scenarios, mean monthly variations are from < 1 to 2 degrees C up to 2039, increasing in the range from <2 to 6 degrees C by 2099, with RCP 8.5 consistently giving the largest increases. Average daily maximum show significant increases from the historical average under all RCP models, with RCP 8.5 showing slightly higher median values and greater variability. The number of hot days (>35 degrees C) is from 6.2 to 6.5 for all RCP scenarios out to 2039, but this increases to 9 to 41 days for RCP 2.6 and RCP 8.5 by 2099

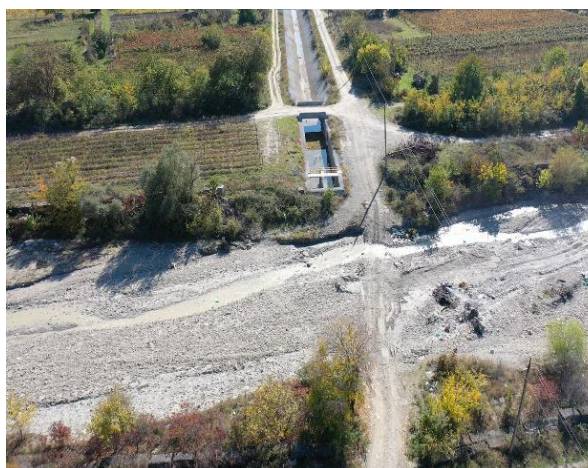
Figure 17: Crossings of Chailuri River and Kvemo Samgori Main Canal⁷⁴

158. The rivers Lakbe and Chailuri cross Lower Samgori's main channel. The Chailuri River runs through the underground gallery of Samgori's main channel (Figure 17), while at the crossing point with Lakbe, the river itself flows through the underground channel (Figure 18).

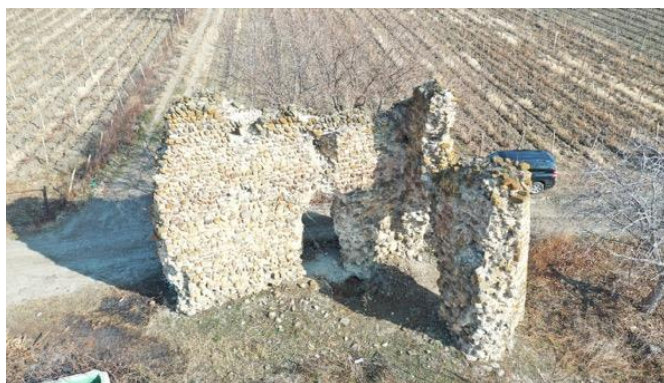
Figure 23: Nameless Tower⁹⁰

190. **N13 – Nameless Tower** – called local Nameless Tower (no official name found), the monument is badly damaged, with only its east and north walls surviving. Other walls are ruined to the ground. The Castle/Tower is built of cobblestones and lime mortar. Its walls are finished with plaster. The outer walls have some fragments of bricks, see Figure 23;

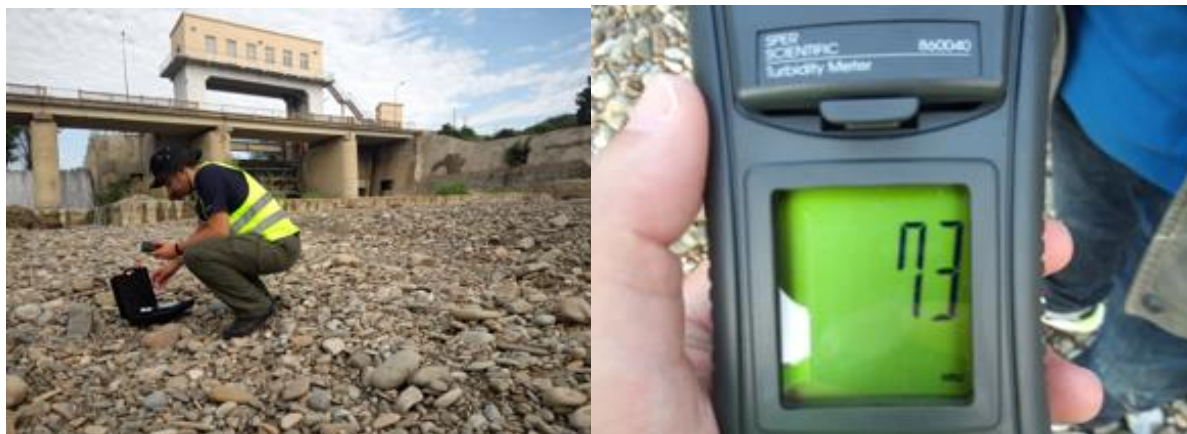
Figure 25: Suspended Solids Measurements⁹³

197. There are two water quality monitoring stations along the lori River, at Sartichala Sasadilo, which are upstream of the project. This makes it hard to establish the water quality baseline⁹². It is known that there is a high level of suspended sediments in the lori River from quarry activities upstream. Instrumental measurements of the concentration of suspended particles in the lori River were accomplished. The mentioned quarries started working at 7:00 am, and instrumental measurements were carried out both, at 6:00 am and 10:00 pm.

198. As the detailed measurements showed, as the aforementioned quarries and processing plants start working, the amount of suspended particles in the River increases almost 5 or 6 times. The amount of suspended particles in water samples taken at 6 am was about 15 NTU (Nephelometric Turbidity Units), while after the mentioned plants started working, the amount of suspended particles in the water was 75 NTU on average.

199. The relationship between NTU and suspended solids is as follows: 1 mg/l (ppm) is equivalent to 3 NTU. Accordingly, every litre of water taken from the river lori contains 23 mg of suspended particles. Accordingly, 9m³ of water taken from the lori River every second contains 0.2 kg of suspended particles which means that a minimum of 1700-1800 kg of suspended particles gets into the irrigation system every day making about 30m³ a month across the whole irrigation system.

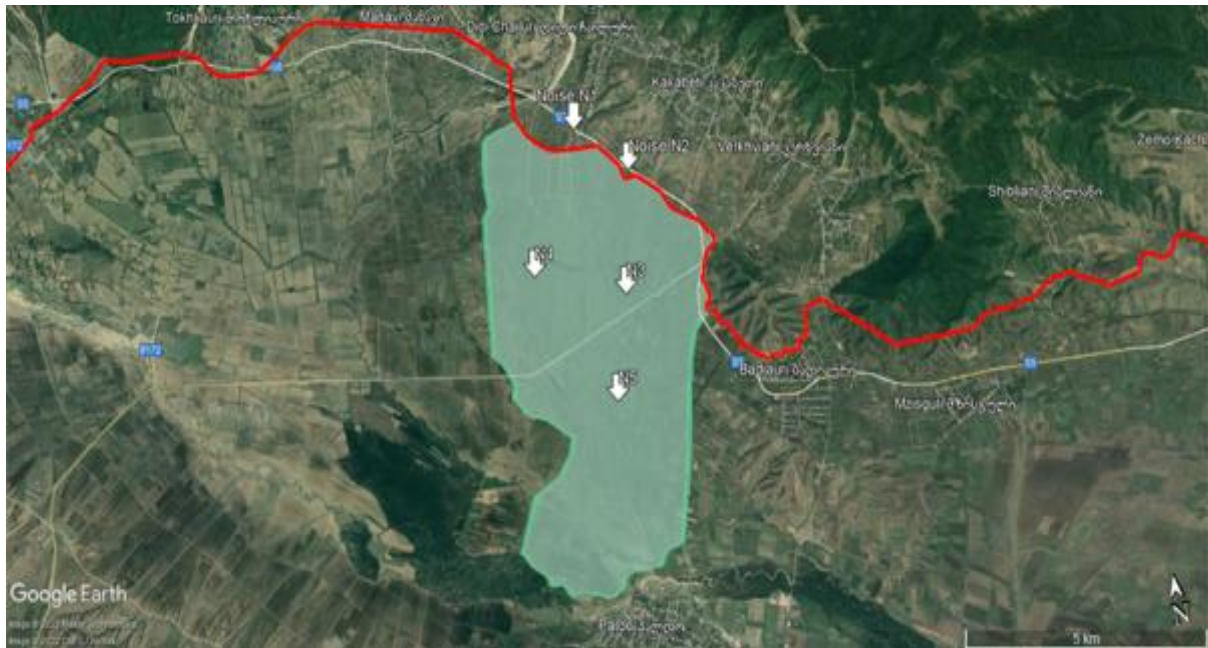
Table 26: Location of monitoring sites¹⁰³

318. Based on the results, the values of noise, vibration and harmful substances in the air are within the admissible norms at all sites. Only in the northern part of the project area, close to the road, the noise levels have increased slightly getting close to the admissible level.

319. As for the 20-15-minute-long noise measurements within the project area (Figure 6.1, points 3, 4 and 5), the obtained noise levels did not exceed 45 dB even during the day (the legally admissible norm is 55 dB).

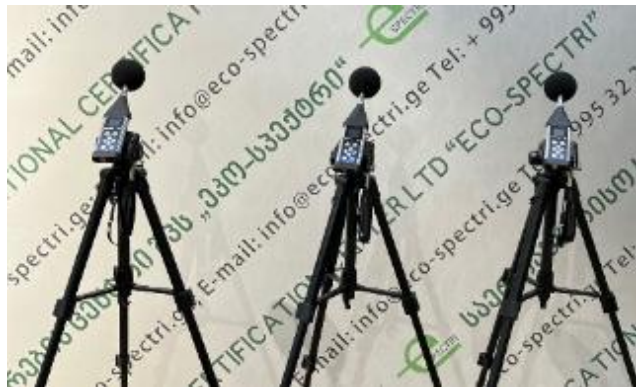
Figure N6.1.2: Organization-owned noise meter

Noise meter configurations during the study were:

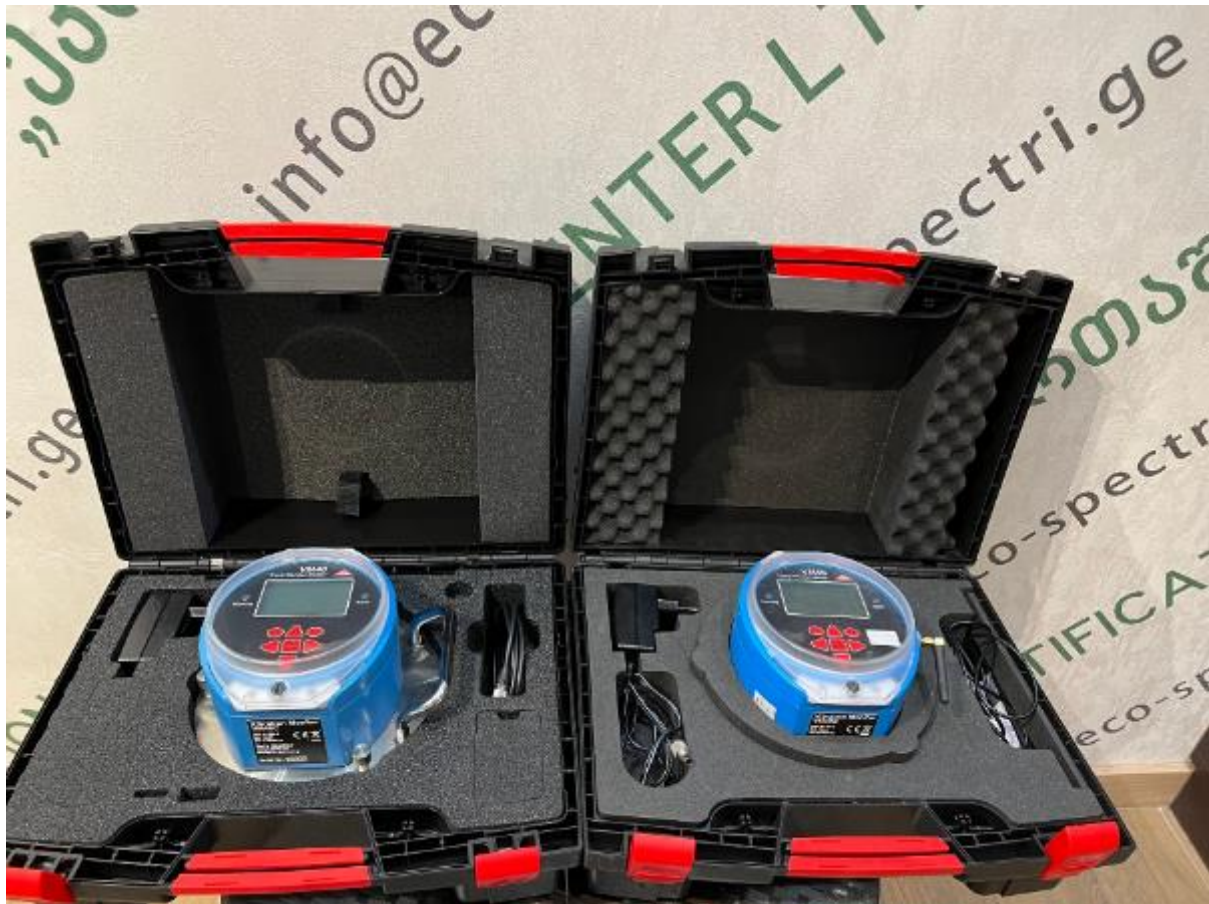
Figure 6.2.1: Triaxial Vibration Monitor VM40A/B

The instrument contains three highly sensitive piezoelectric systems for vibration measurement of all three special dimensions. The signal processing is controlled by a microprocessor. The VM40 is operated via its seven keypad buttons and illuminated LCD display. The measurement data can be transferred to a PC via the USB interface. The instrument also has a port for connecting a charger and a relay output for the external signaling of vibration occurrences.

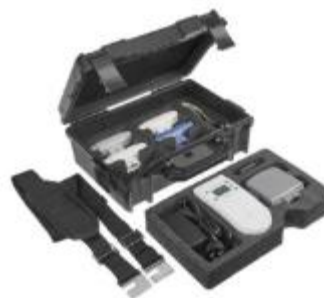
Figure 6.3.2.: “Aeroqual Series 500 Portable Air Quality Monitor”

The pictures 6.3.1 - 6.3.2 - below shows the “Aeroqual Series 500 Portable Air Quality Monitor”.

The device has different sensors for each type of harmful substance. The device has the following types of sensors:

- Gas sensitive semi-conductor sensor (GSS);
- Gas sensitive electrochemical sensor (GSE);
- Laser Particle Counter (LPC);
- Photo Ionization Detector (PID).

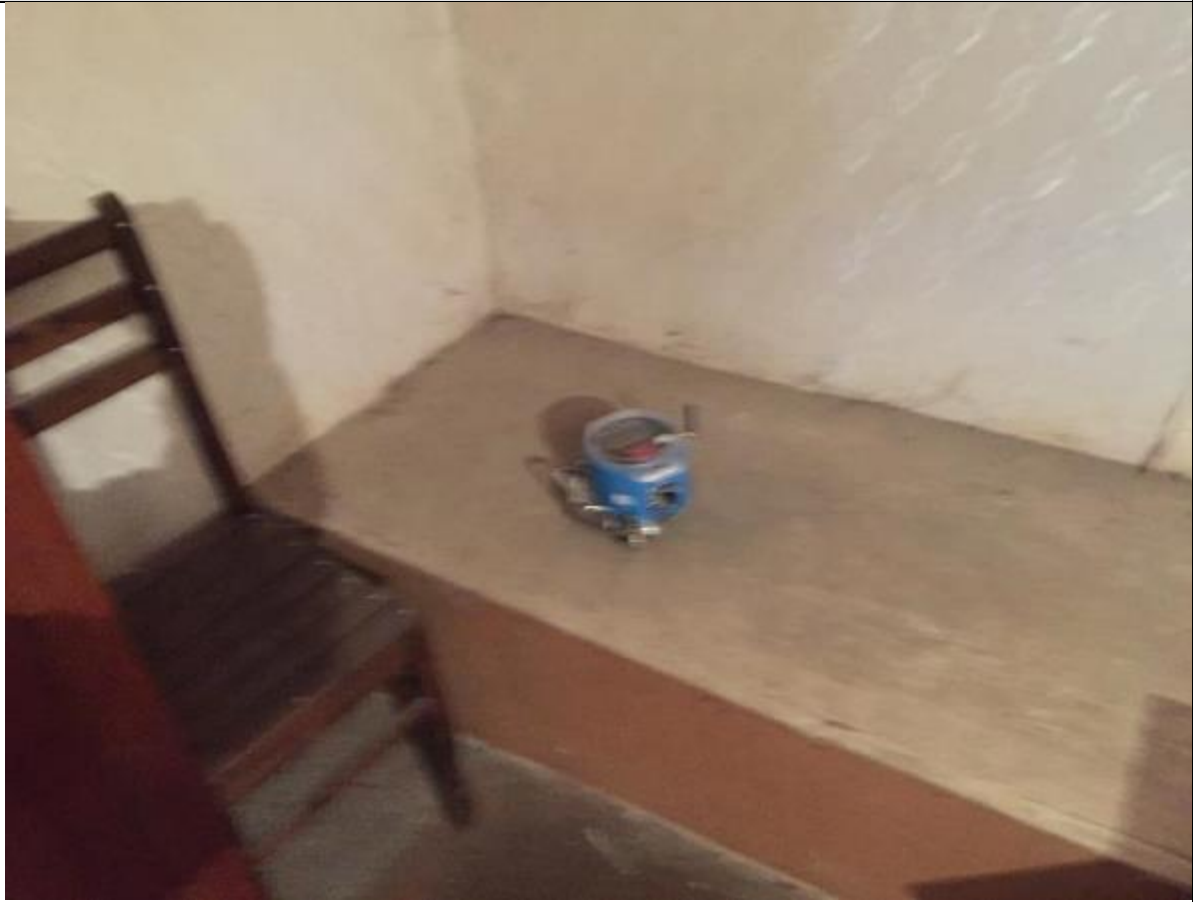
Measurement protocol N1

5. Environmental conditions	Closed space; The smooth surface of the ground.
6. Subjective observations	The vibration of the working specifics doesn't affect on the general condition
7. Measuring chain	Triaxial Vibration Meter VM40B Serial number: 180665 Calibration Date: June 2021 Measurement method: DIN 4150-3 Settings: short res. found.: Frequency range: 1-80 Hz Trigger mode: 060s + events Measurement processing and report generation done with VM40MDB software.
8. Measurement result	
8.1 Event chart

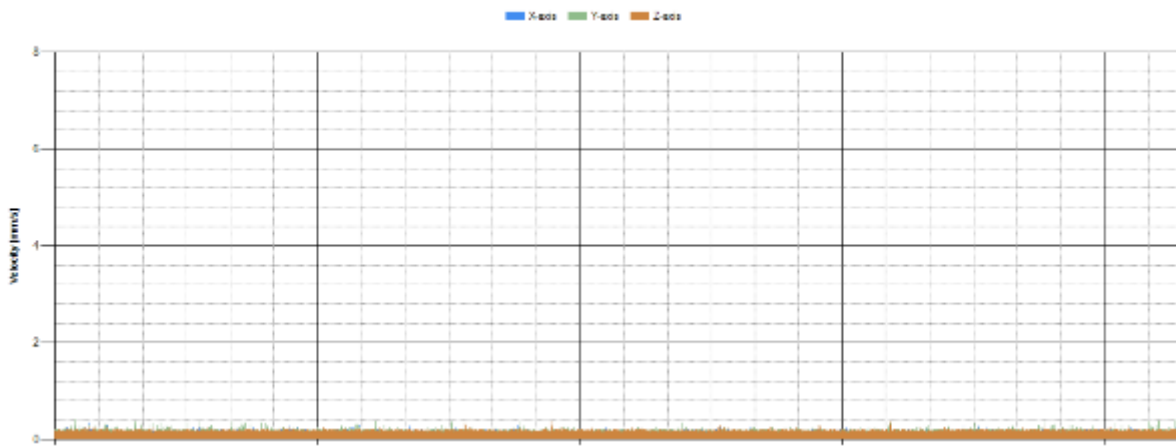
Measurement protocol N1

Date	Time	X-axis	Y-axis	Z-Axis	Unit	Trigger event
27.04.2022	12:00 - 13:00	0,17	0,20	0,18	mm/s	(T)
27.04.2022	13:00 - 14:00	0,17	0,20	0,18	mm/s	(T)
27.04.2022	14:00 - 15:00	0,18	0,20	0,18	mm/s	(T)

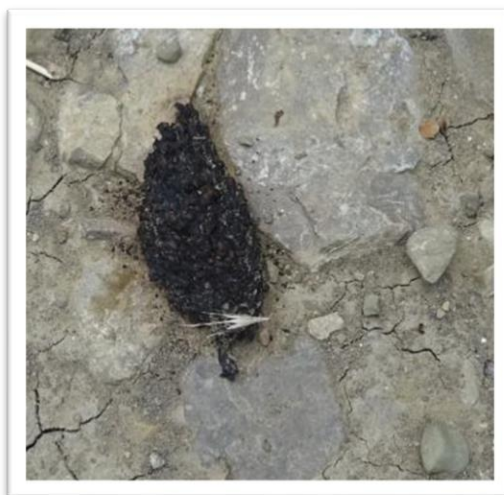
jackal (*Canis aureus*) excrements

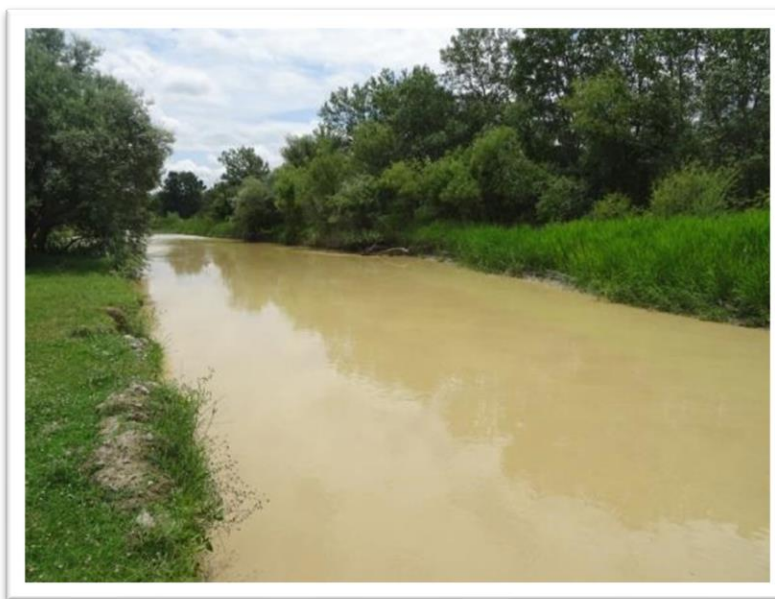
Iori River (potential otter habitat) adjacent to the project area

As mentioned above, the lori River is located near the project area, which is a potential otter habitat. This section was thoroughly visualized during the study to detect the signs of otter (burrow, traces, excrements, etc.). However, none of them were observed. Although no signs of

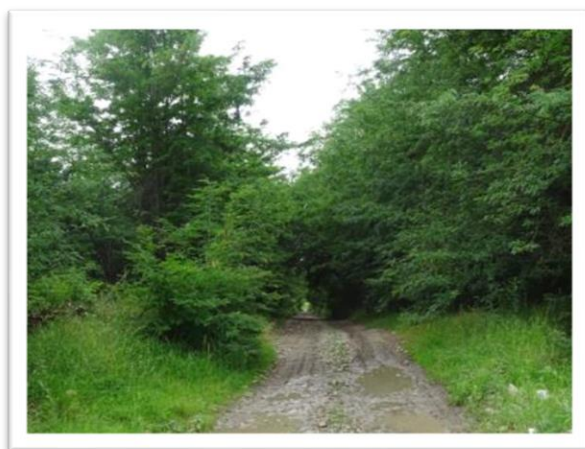
Windbreak zone in the project area

Although the project area is an agricultural landscape, so-called sensitive habitats have been still identified during the study. Such habitats are mainly presented by windbreaks, which include poplar, honey locust, ash, black Locust, aspen, etc. Such windbreaks are a nesting habitat for various birds. So, the impact on windbreaks should be minimum during the works.

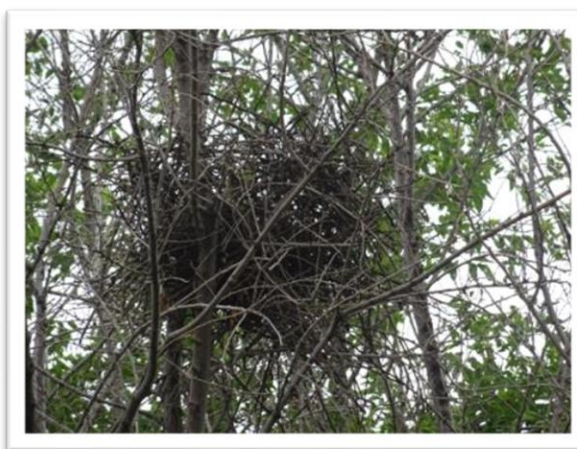
Nest of a Black-billed Magpie in the windbreak zone

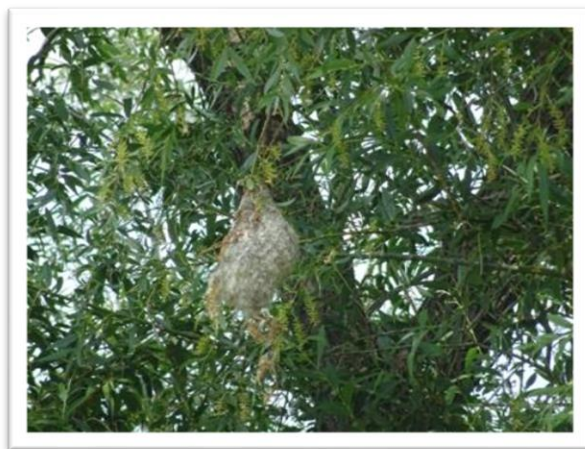
A nest of the Eurasian Penduline Tit in the windbreak zone

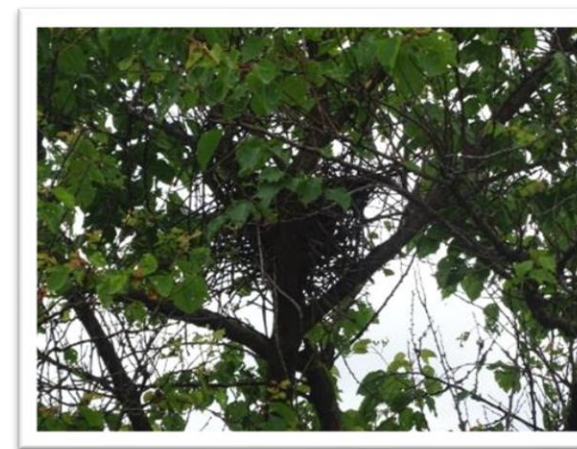
Nest of a Black-billed Magpie in the windbreak
